## SALES REPORT: CATERPILLAR 289D3 - SN BT900### - Year 2021

This Report is a summary about observations came out from technical inspection done by our specialised technician.

**Model:** 289D3

**Serial Number:** BT900###

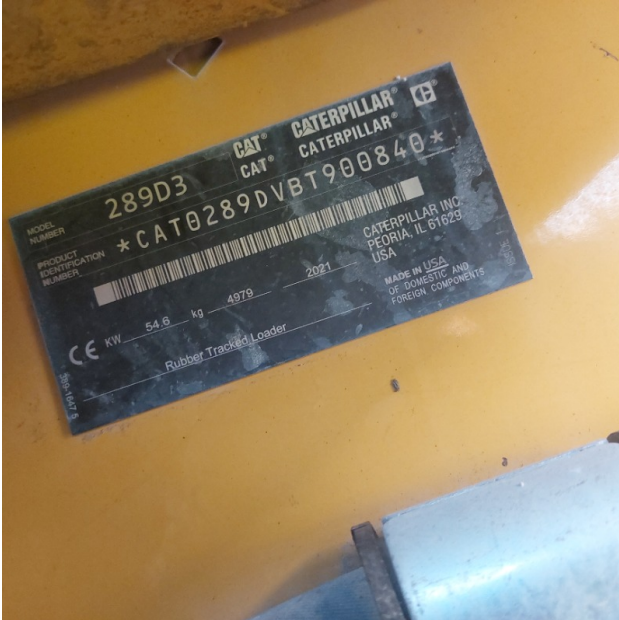
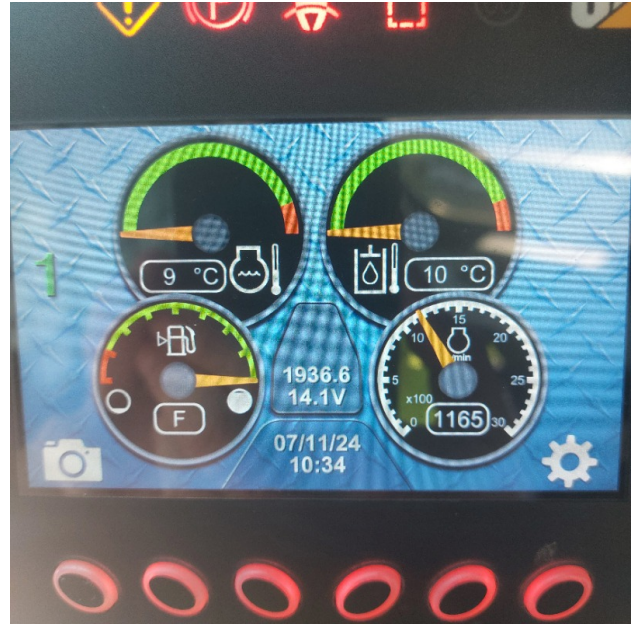
Photos

◆ Boom structure: Good

Presence of welding/cracks : No
