## SALES REPORT: CATERPILLAR 242D3 - SN ME600630 - Year 2019

This Report is a summary about observations came out from technical inspection done by our specialised technician.

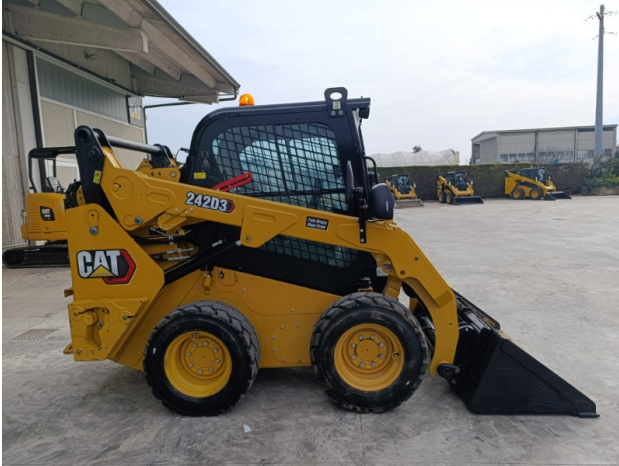
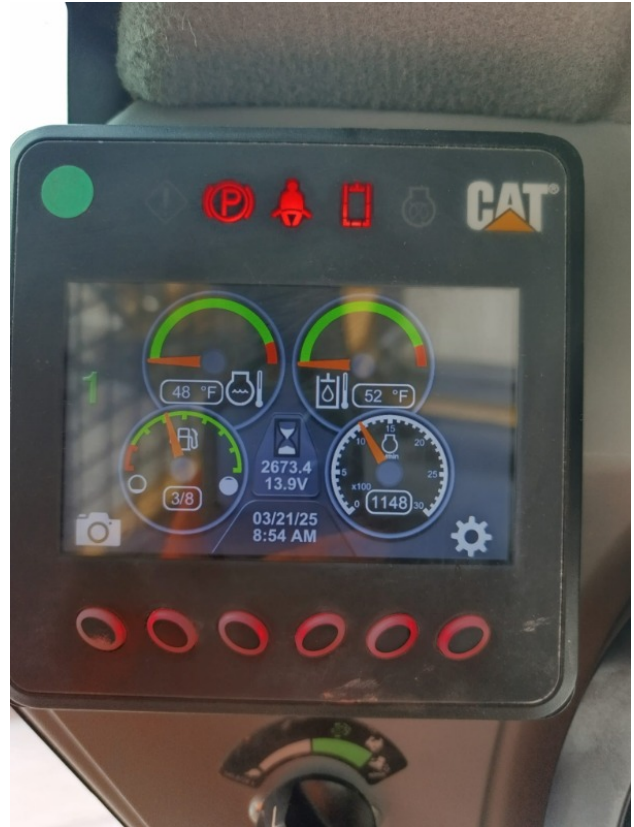
Photos

◆ Boom structure: Good

Presence of welding/cracks : No
