SALES REPORT: CATERPILLAR 323F - SN MFY20289 - Year 2019

This Report is a summary about observations came out from technical inspection done by our specialised technician.

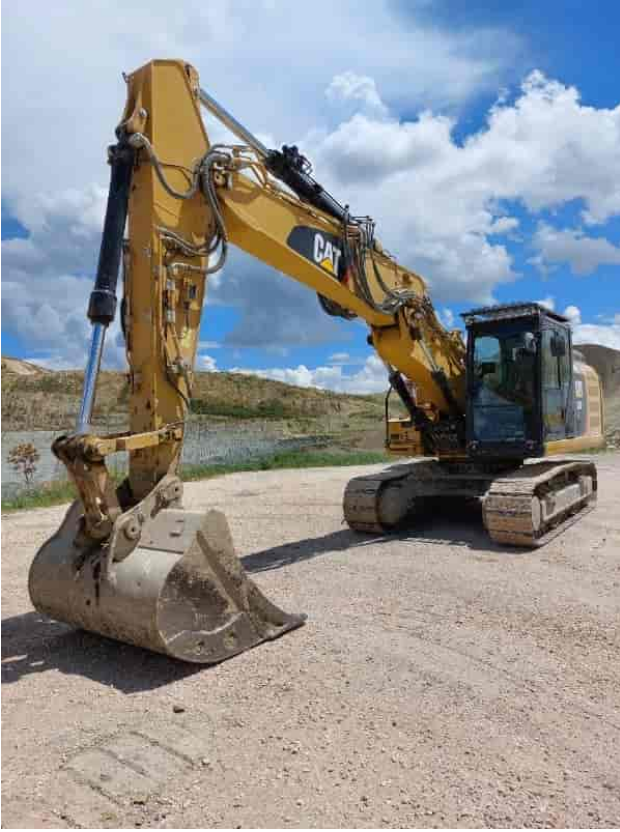
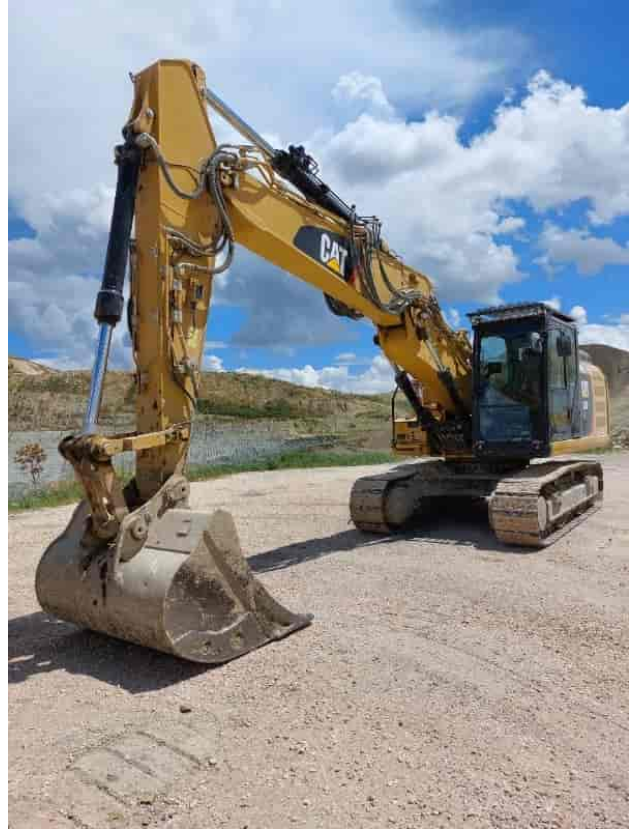
◆ Boom structure: Very good

Presence of welding/cracks : No

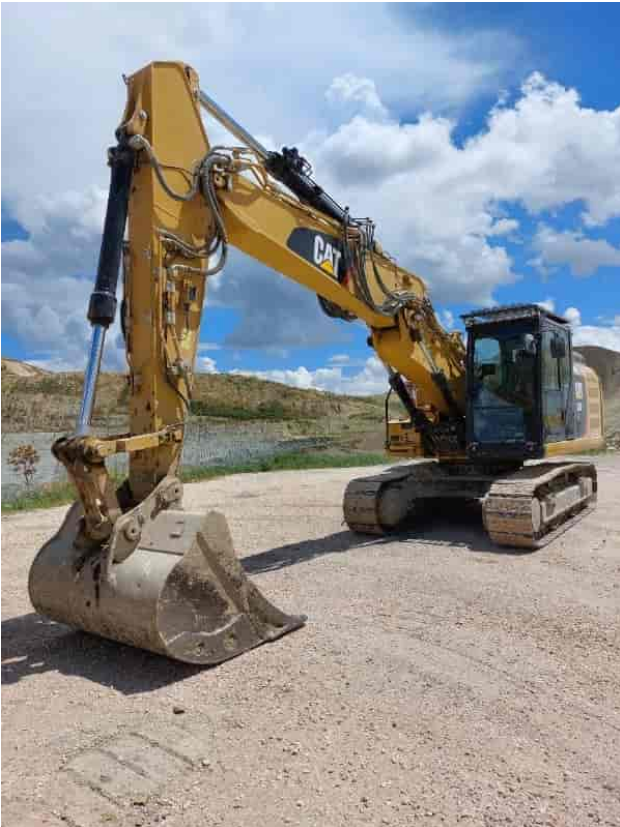
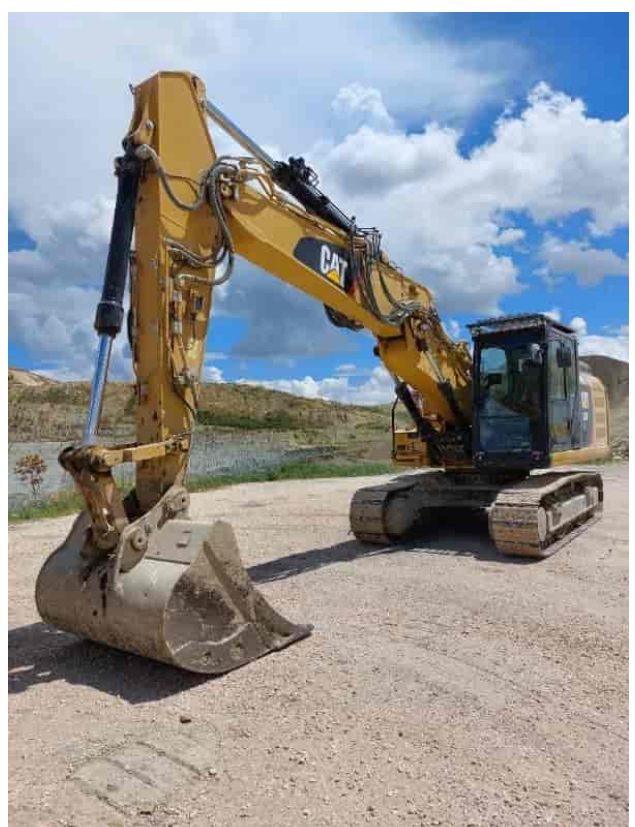
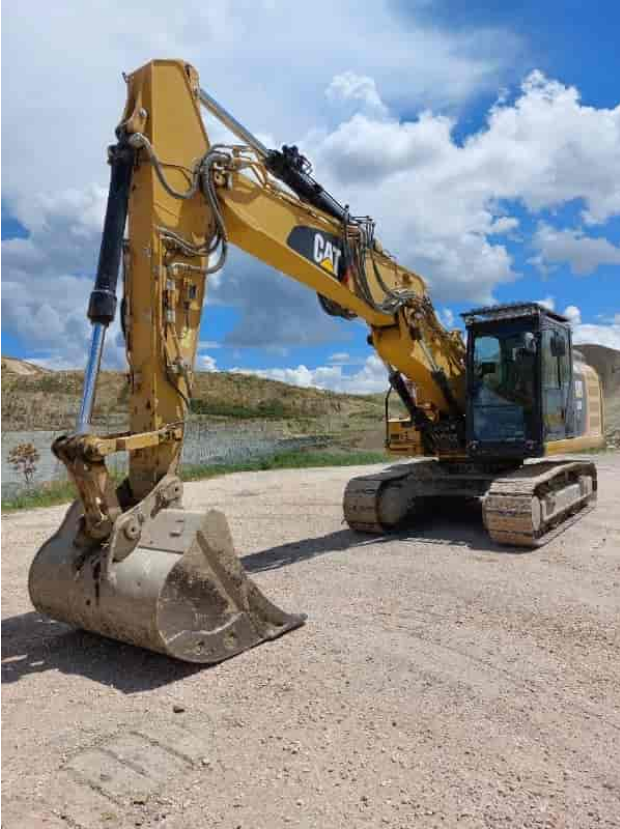
◆ Stick structure:

Very good

Presence of welding/cracks : No
