## SALES REPORT: NEW HOLLAND NHW170#KFNHK - SN N7HE52217 - Year 2008

This Report is a summary about observations came out from technical inspection done by our specialised technician.

**Model:** NHW170#KFNHK

**Serial Number:** N7HE52217

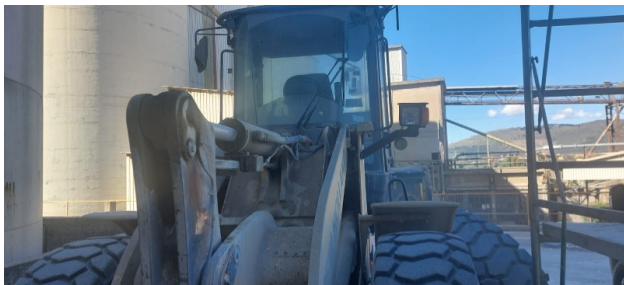
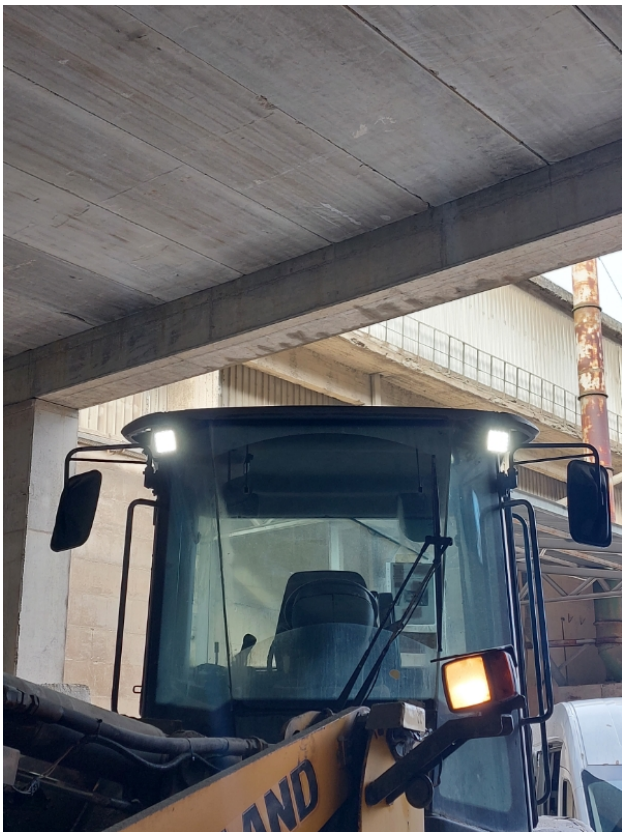
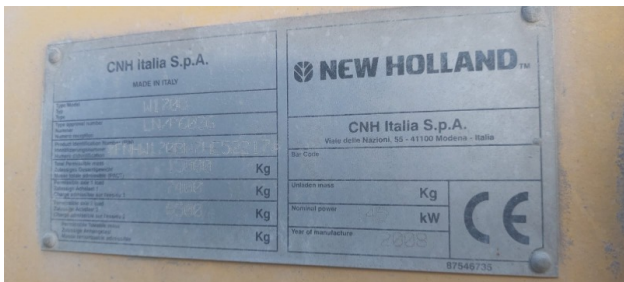
Il contaore e':

Funzionante
