## SALES REPORT: CATERPILLAR 323F - SN MFY20288 - Year 2019

This Report is a summary about observations came out from technical inspection done by our specialised technician.

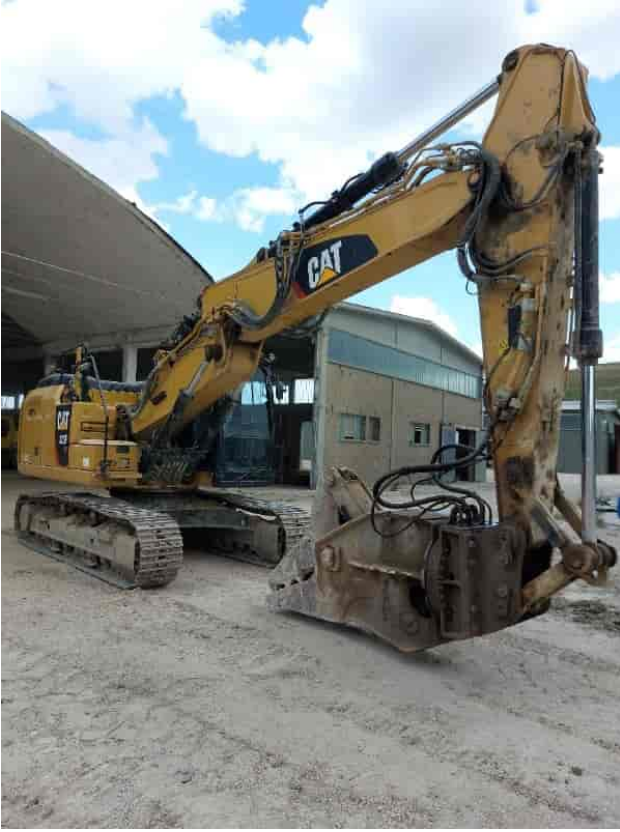
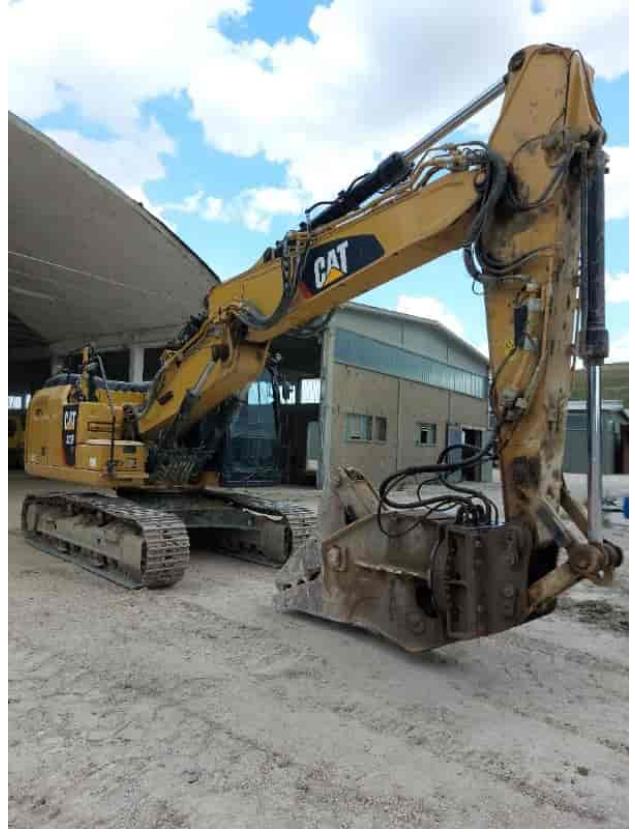
◆ Boom structure: Very good

Presence of welding/cracks : No

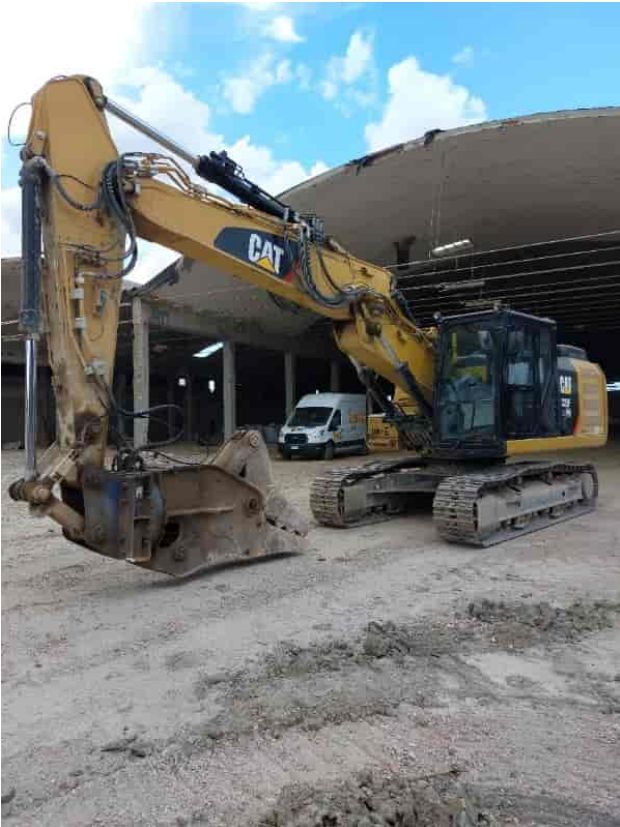
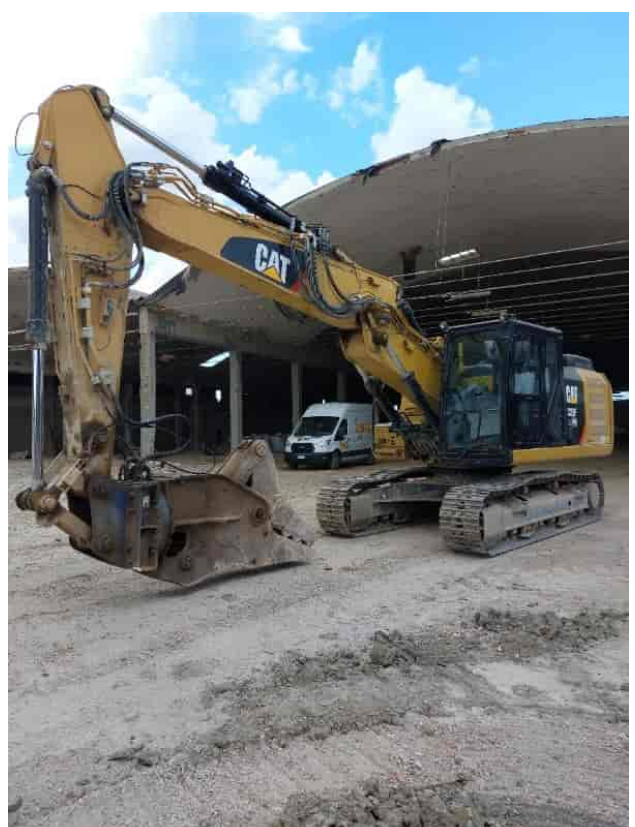
◆ Stick structure:

Very good

Presence of welding/cracks : No
