## SALES REPORT: CATERPILLAR 315 NG - SN YDE00437 - Year 2022

This Report is a summary about observations came out from technical inspection done by our specialised technician.

**Model:** 315 NG

**Serial Number:** YDE00437

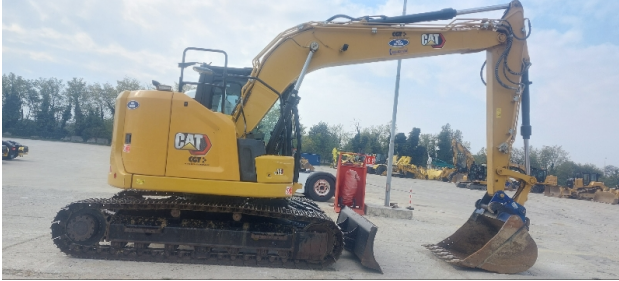
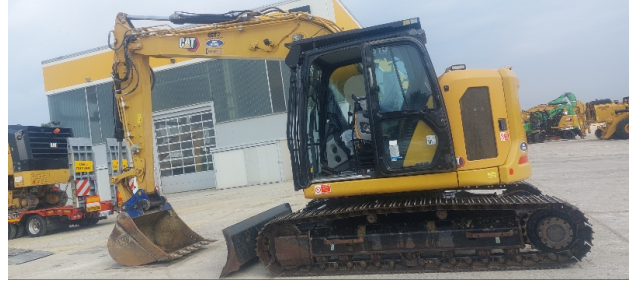
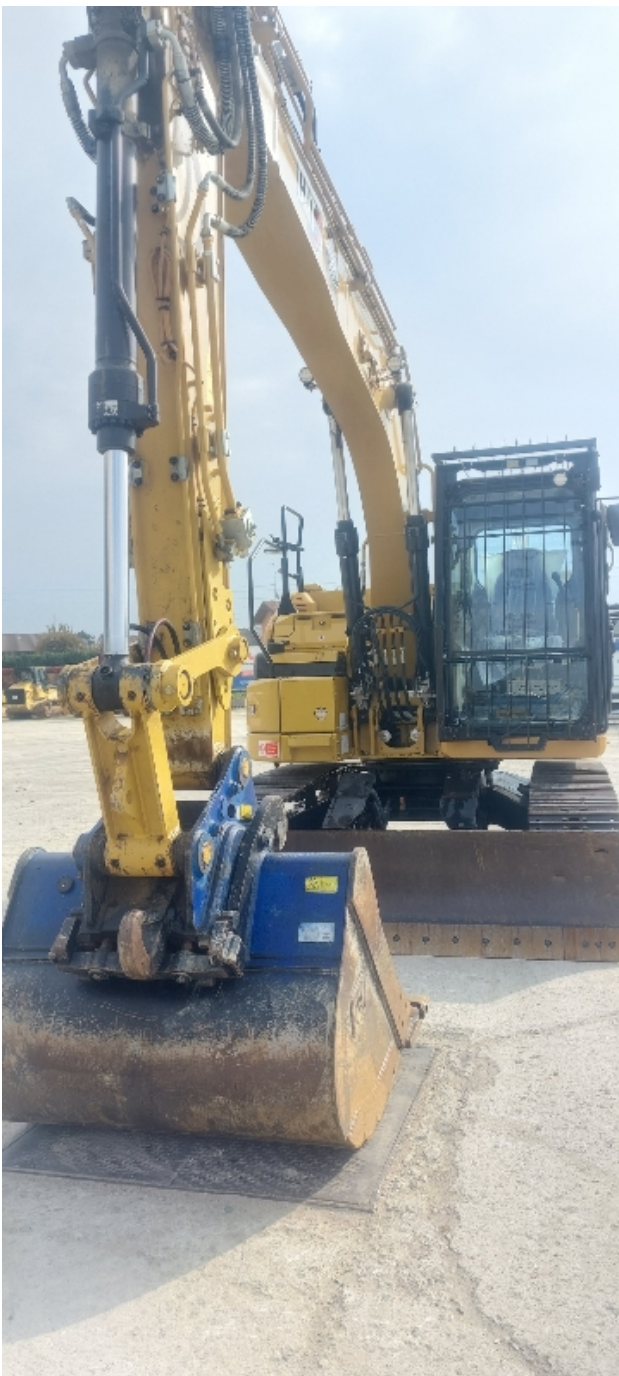
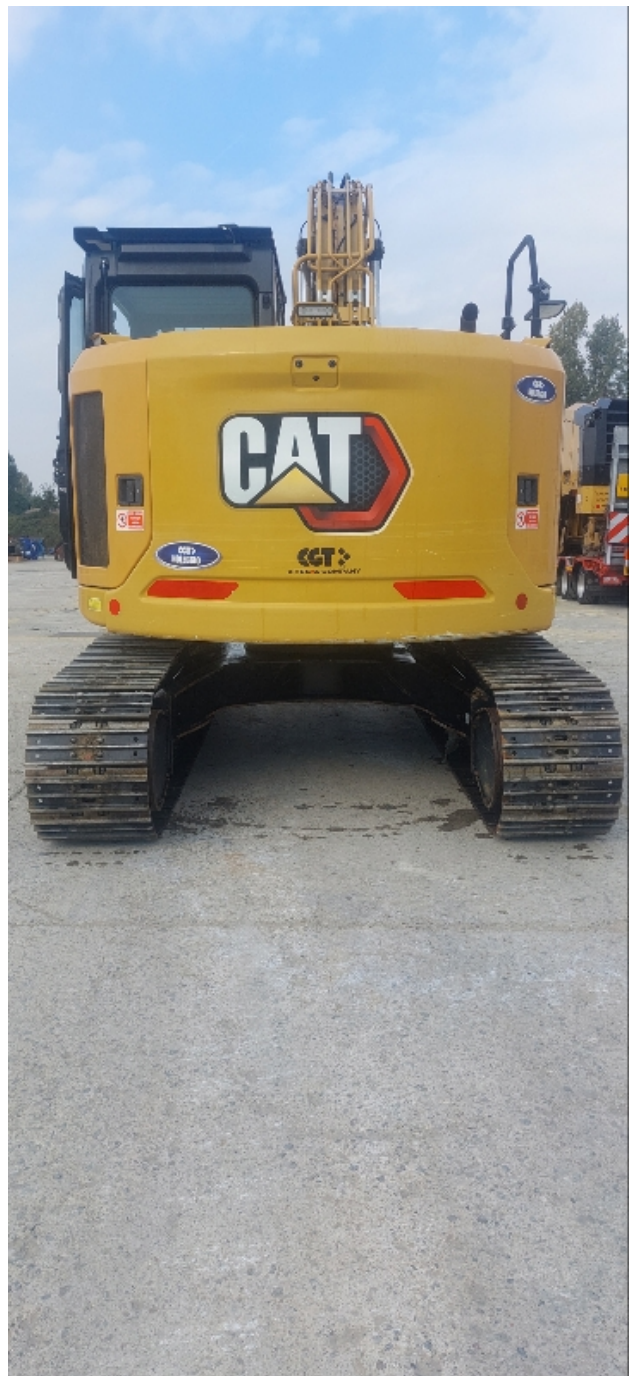
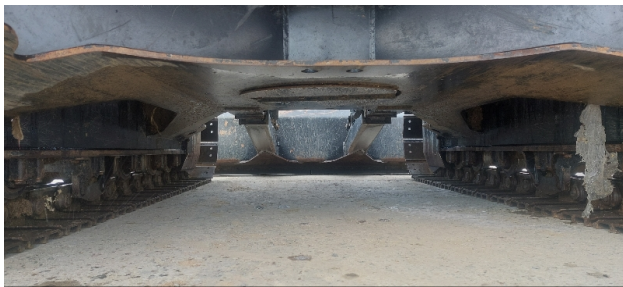
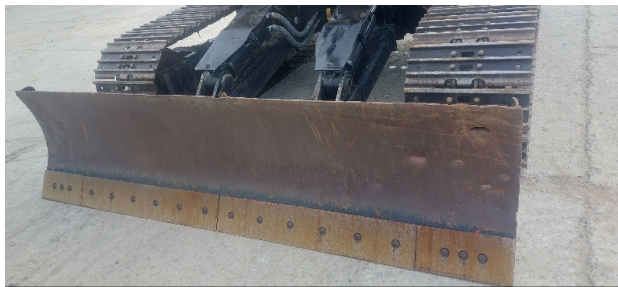
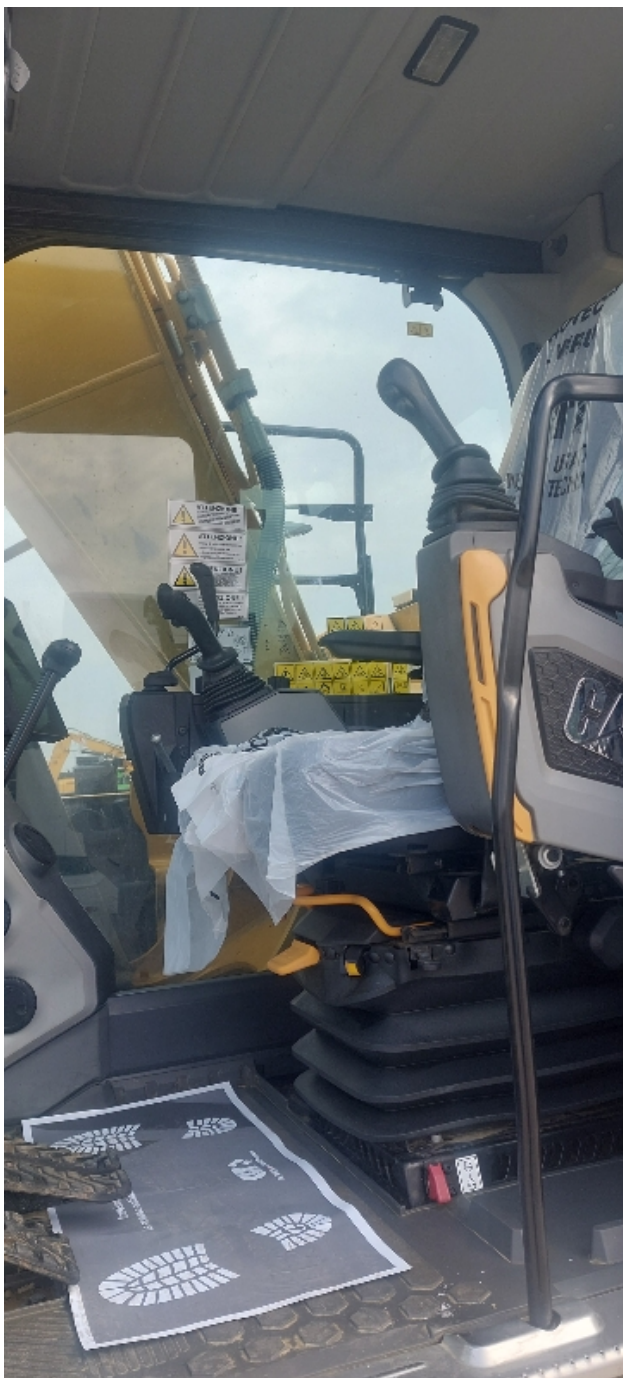
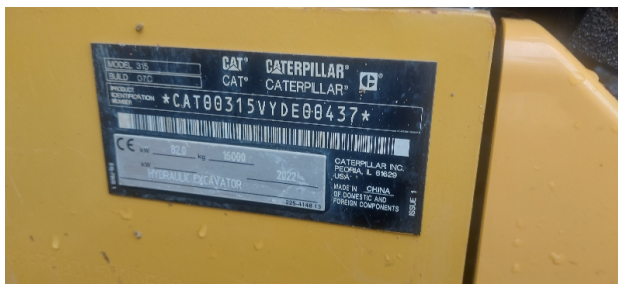
## MACHINE PHOTOS

| ◆ Painting Conditions | Good |

| ◆ Counterweight conditions: | Good |

| ◆ Frame/Bumper conditions: | Good |
