SALES REPORT: CATERPILLAR 330F - SN JFR20044 - Year 2017

This Report is a summary about observations came out from technical inspection done by our specialised technician.

Model: 330F

Serial Number: JFR20044

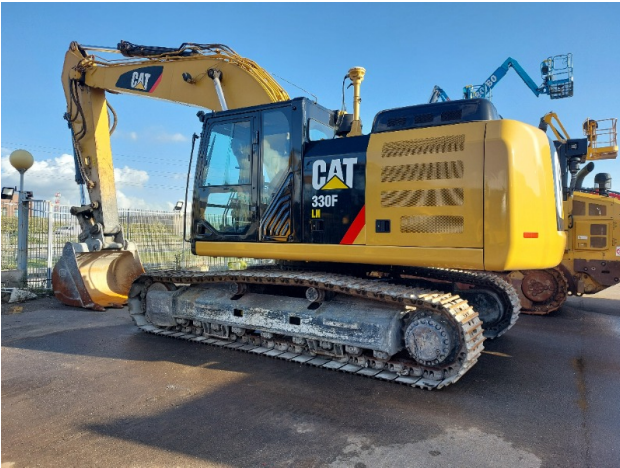
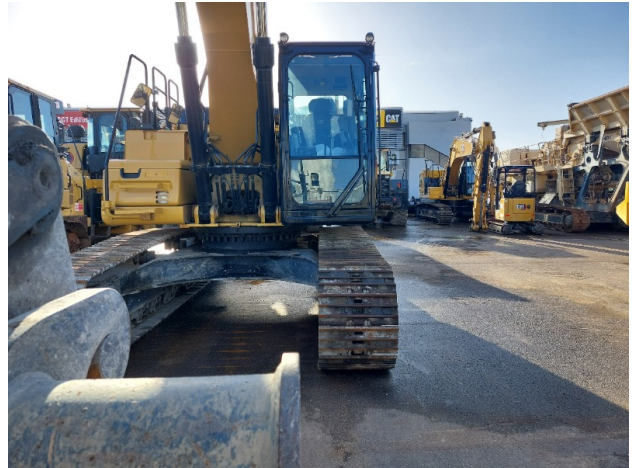
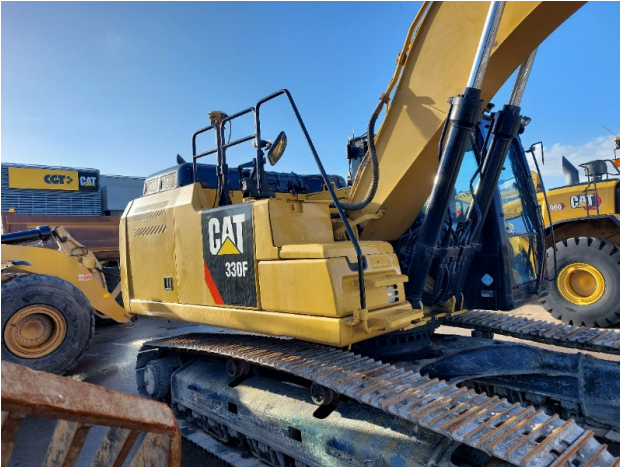
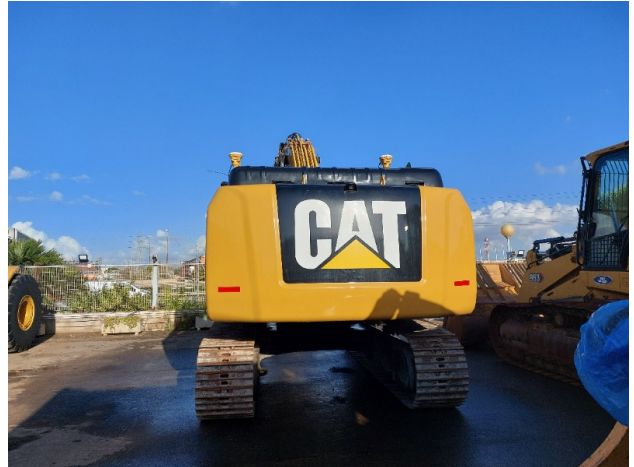
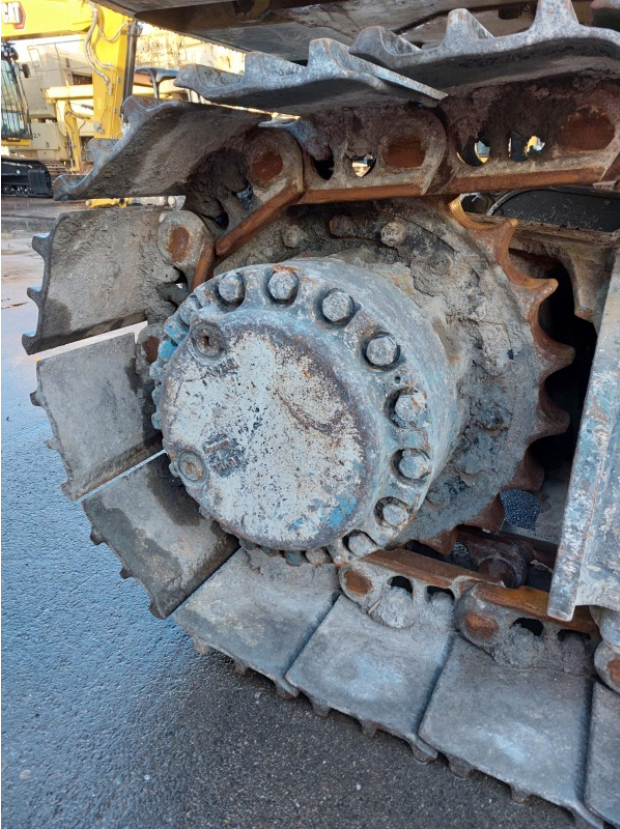
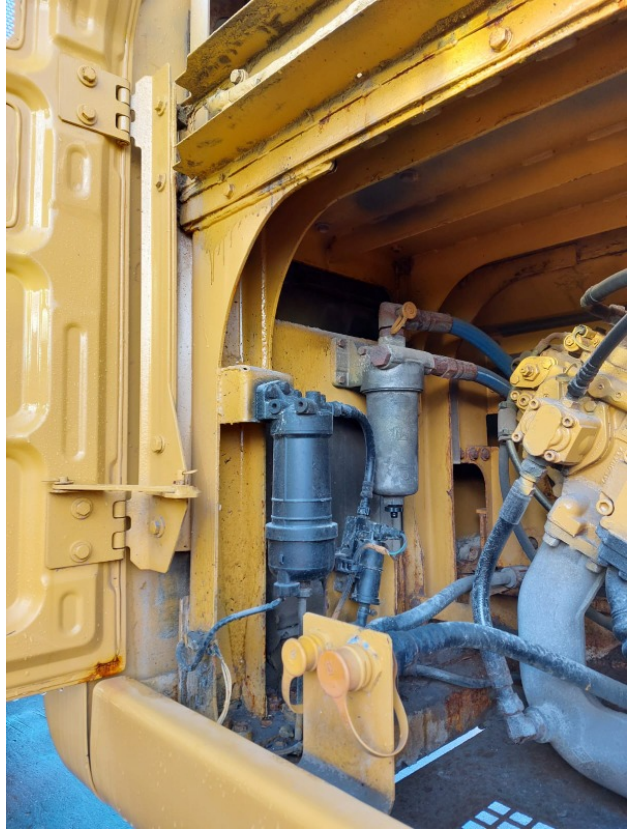
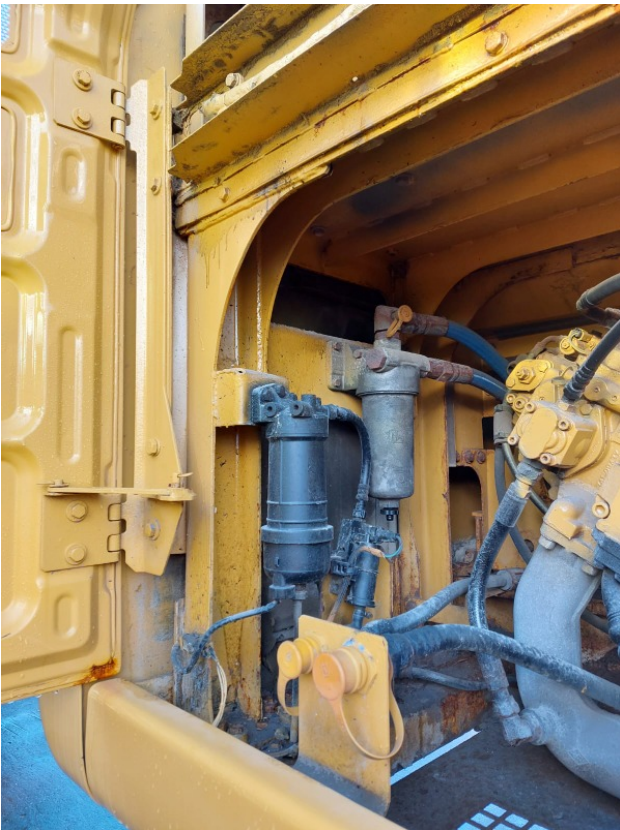
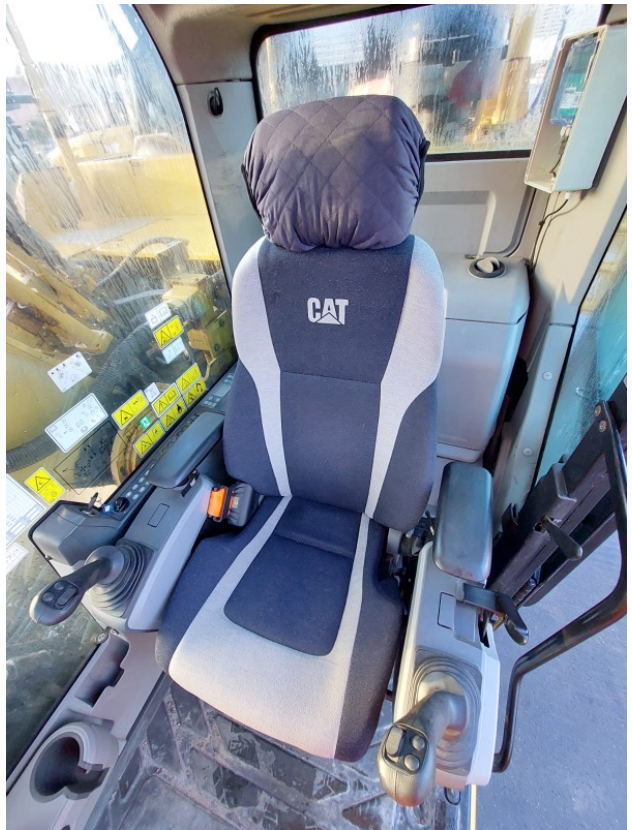
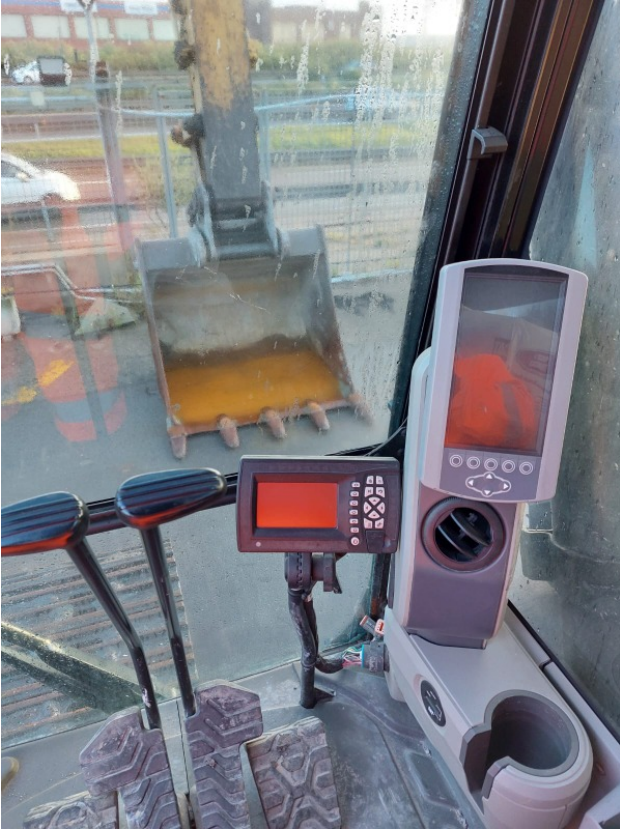
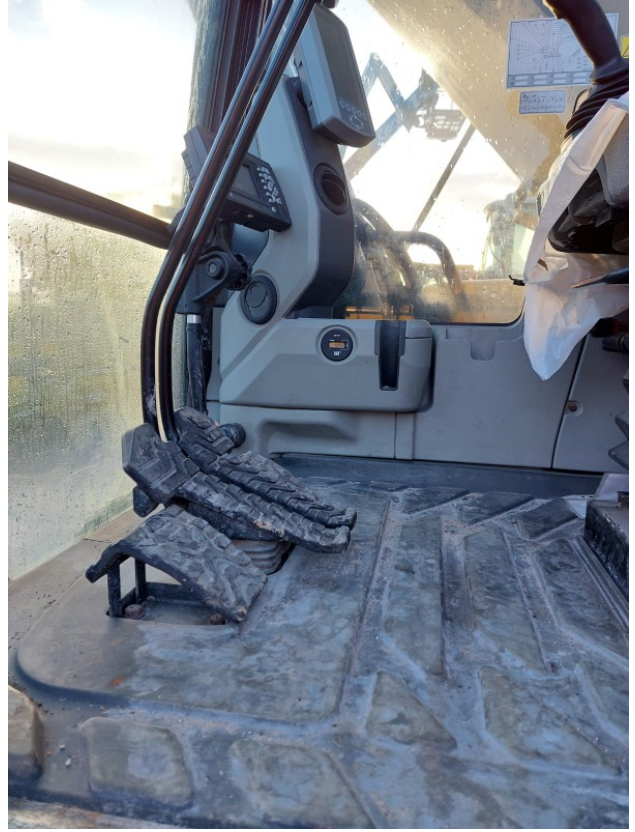
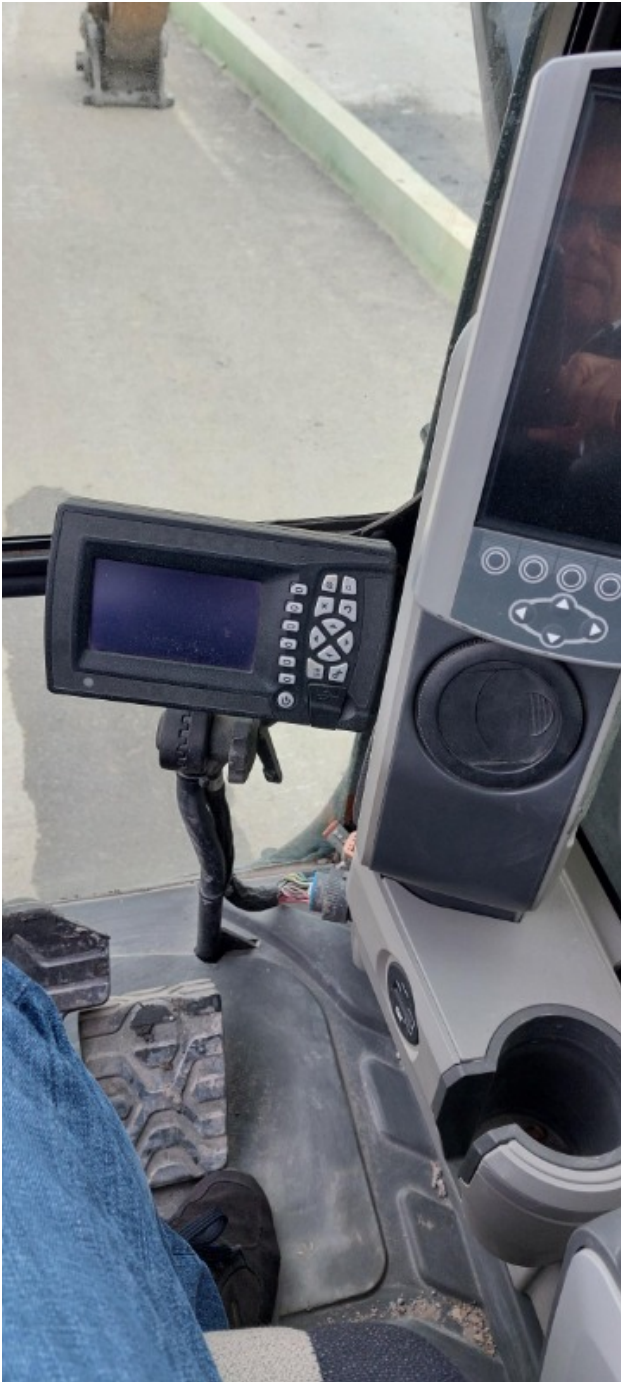
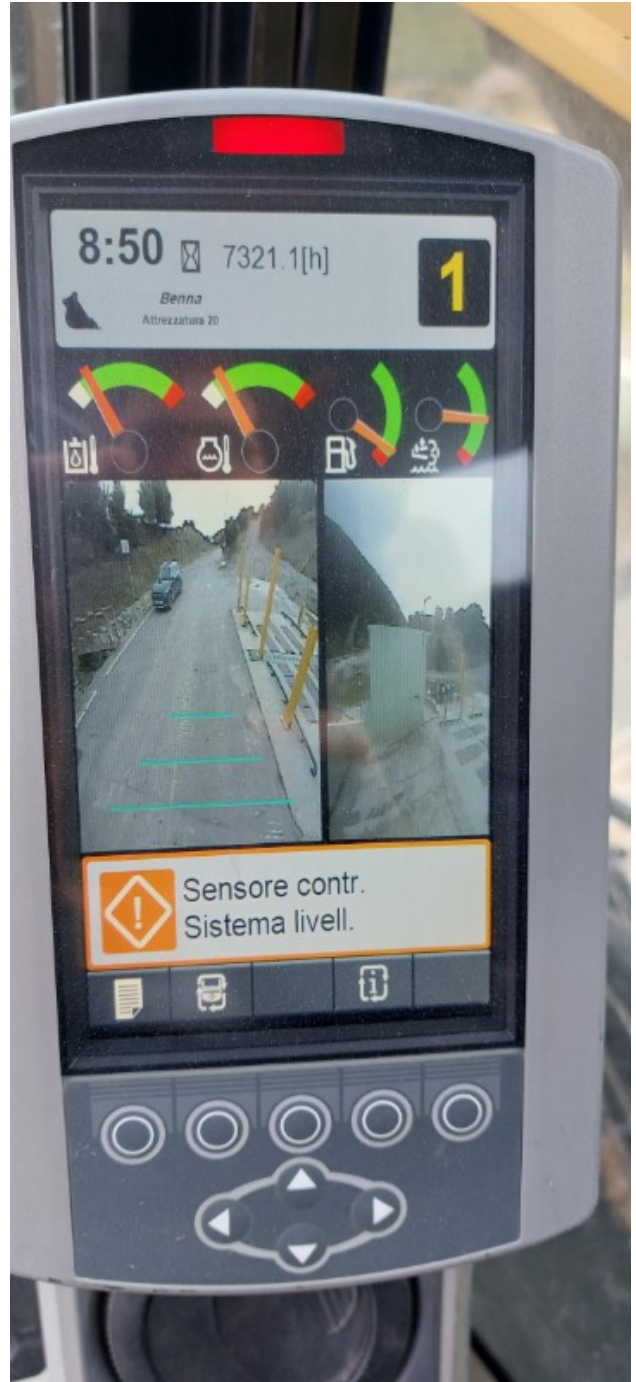
MACHINE PHOTOS

• Machine type Standard • Boom type Mono boom • Boom check valves • Stick check valves • Plant features Versatility • Quick coupler Mechanic Cat cw45s • Bucket Standard MM 1500 Get undefined Una • Truck type Fixed • General Truck Residual 50% Tendingoli bloccati. Corrosione diffusa. Recentemente sabbiato e riverniciato • Cabin type Fixed standard • Air Conditioning system • Product Link • 29073 Kg • CE Mark • CE Certificate • Use and maintenance manual COFANI E parti con ruggine sabbiato e ruverniciate salvo cofano motore. Valvola EGR nuova. Nessun allarme attivo. • EPA Family Code: HPKXL07.0BN1

◆ Il contaore è:

Funzionante

◆ Annotazioni sul:

Contaore digitale ore 4.493. Quello analogico funziona male
