SALES REPORT: CATERPILLAR AP600D - SN TFM00230 - Year 2010

This Report is a summary about observations came out from technical inspection done by our specialised technician.

Model: AP600D

Serial Number: TFM00230

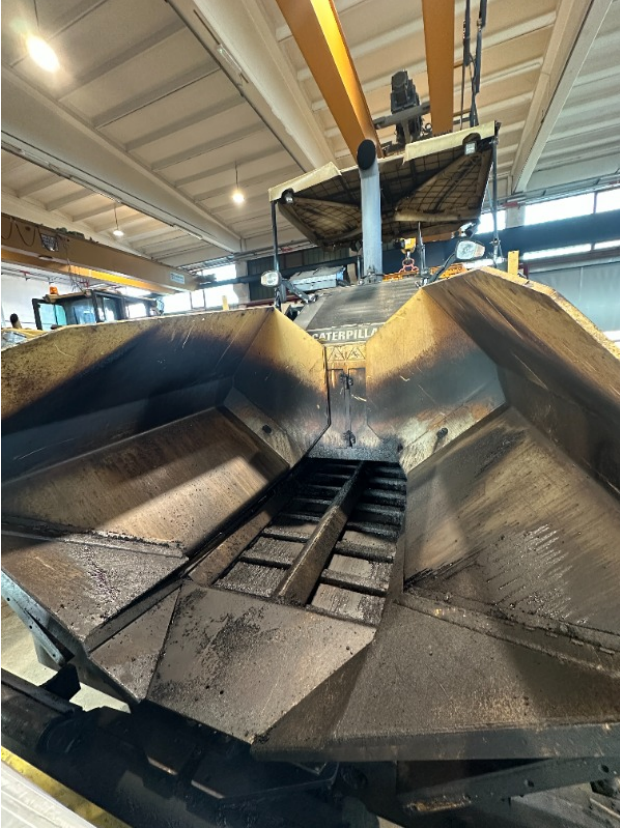
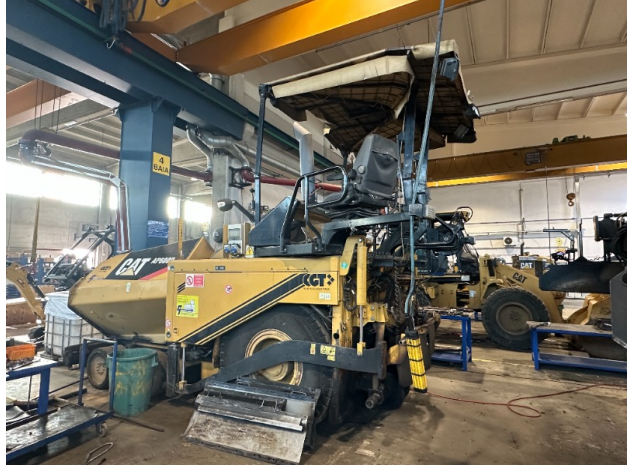
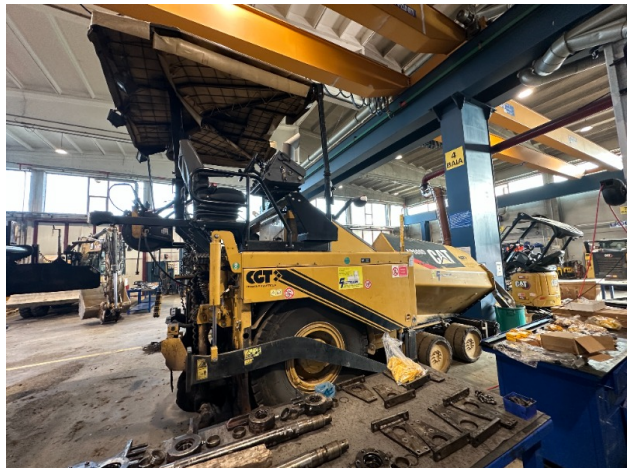
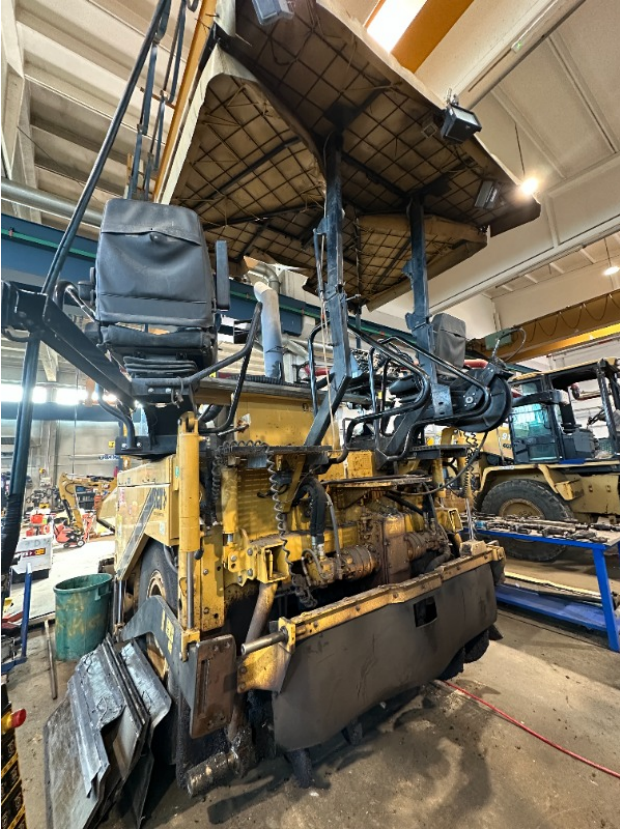
MACHINE PHOTOS

◆ Painting Conditions	Good
◆ Spar conditions:	Good
◆ Residual % - Tyres/Track:	40
◆ Residual % - Cushion:	40
◆ Seat condition:	Very good
◆ Engine working conditions:	Very good
◆ Radiator conditions:	Very good
◆ Batteries/Cables conditions:	Good

◆ Hydraulic pump conditions:	5 mt
◆ Brakes and steering clutch conditions:	20
◆ Final drives conditions:	30
◆ Residuo % Nastri:	40
◆ Residuo % Fondi	20
◆ Apertura massima Allargamenti (se presenti):	no
◆ Annotazioni su:	Banco da revisionare, tamper non integri, piastre al 20% alcune resistenze difettose
