SALES REPORT: HITACHI ZX240#KHITA - SN 5YL00700### - Year 2015

This Report is a summary about observations came out from technical inspection done by our specialised technician.

MACHINE DATA

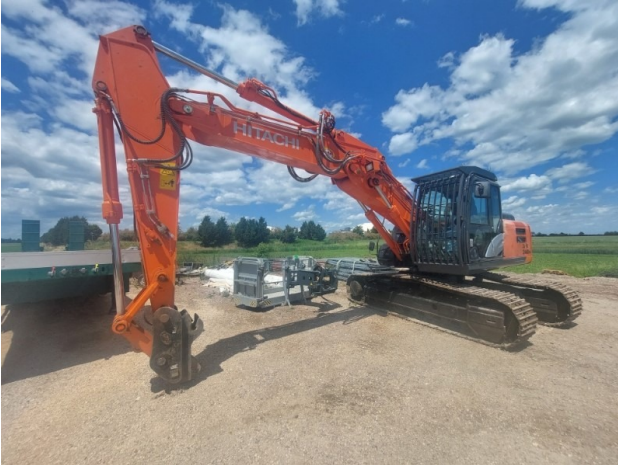
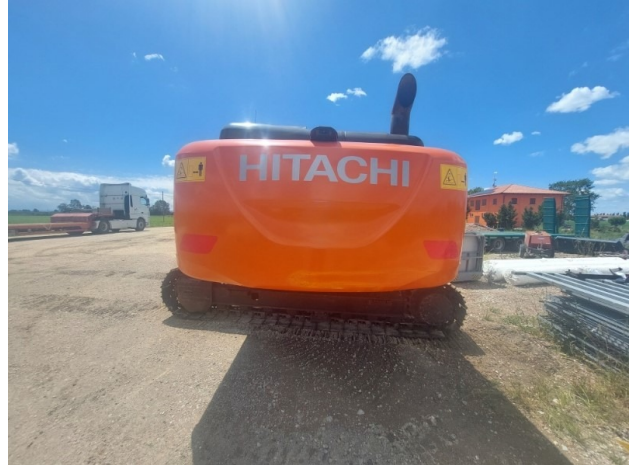
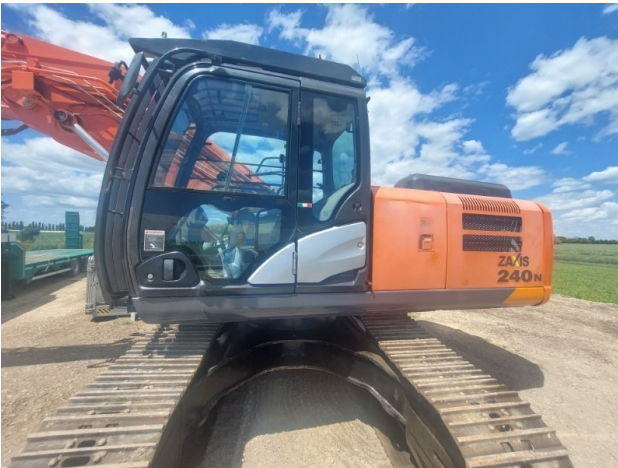
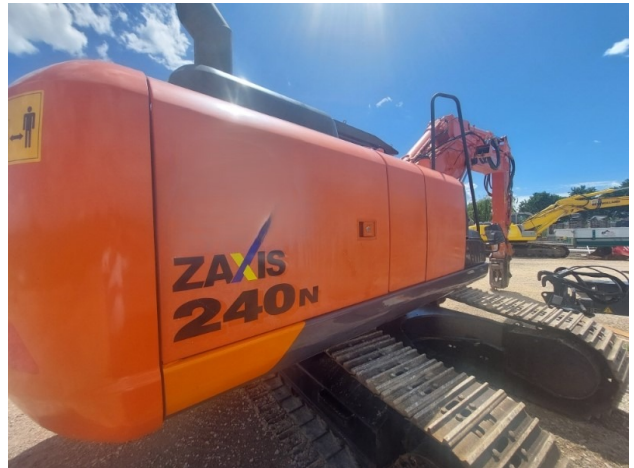
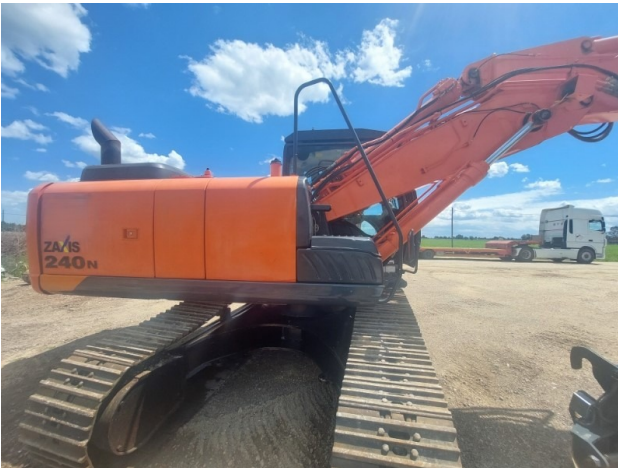
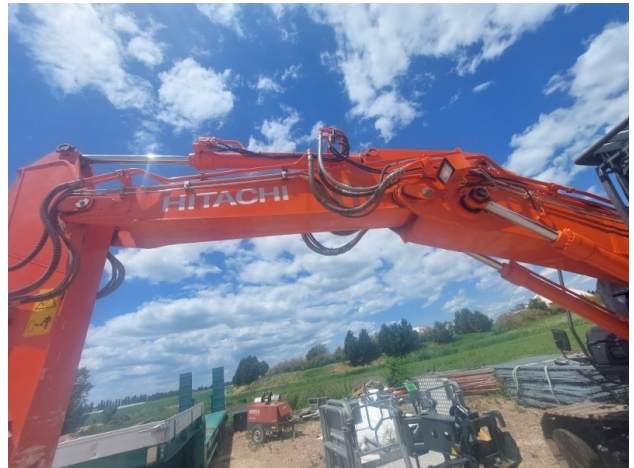
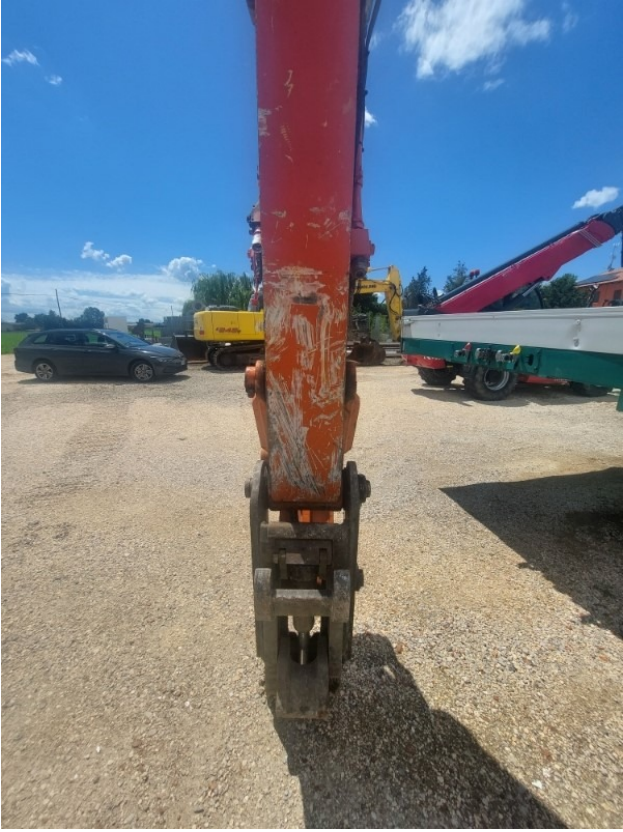
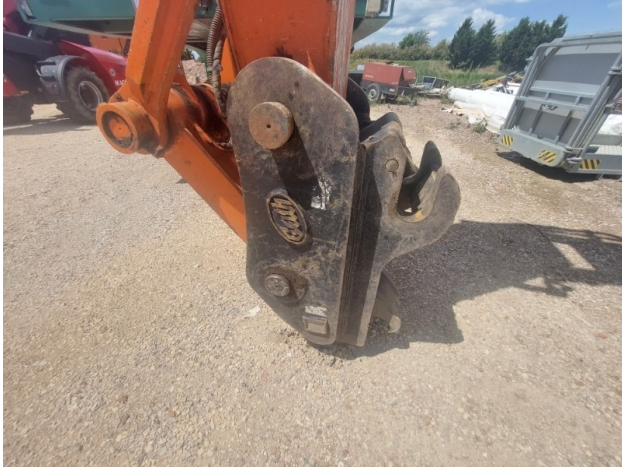
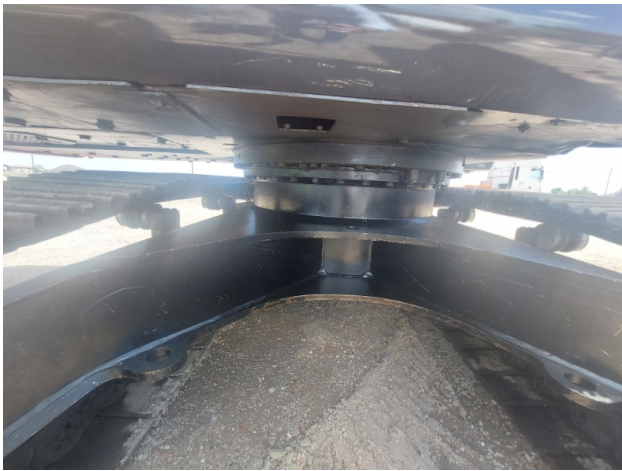
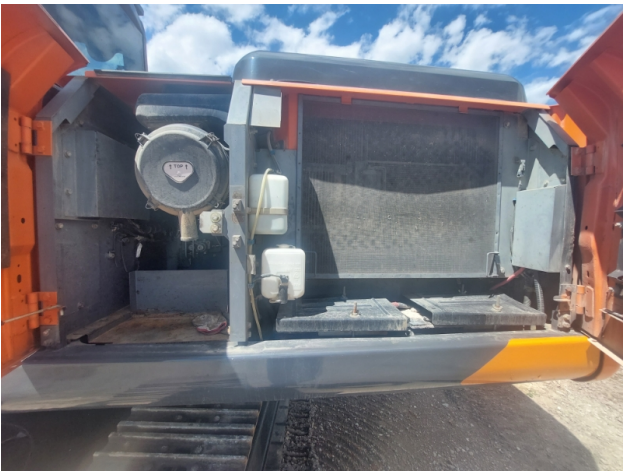
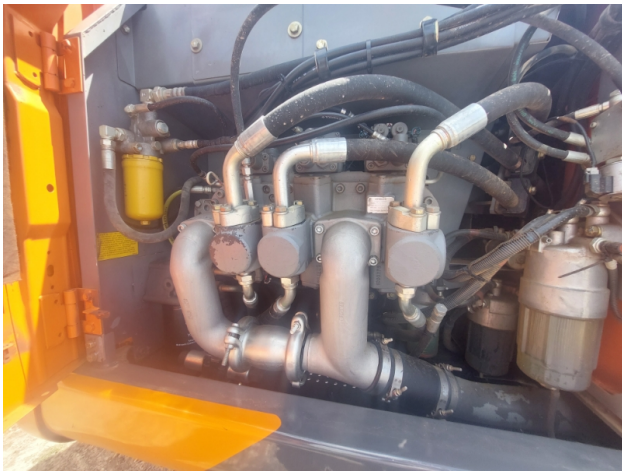
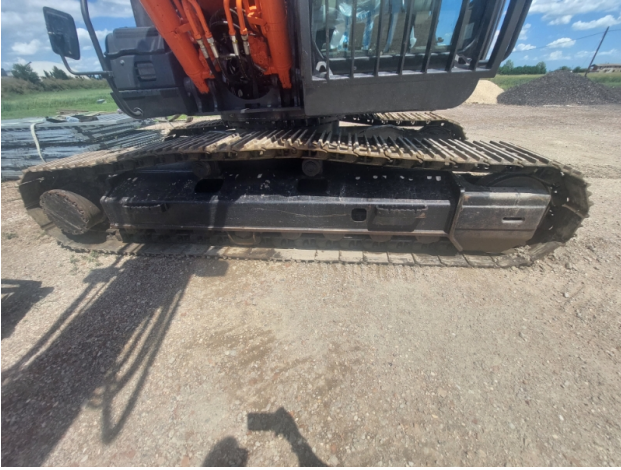
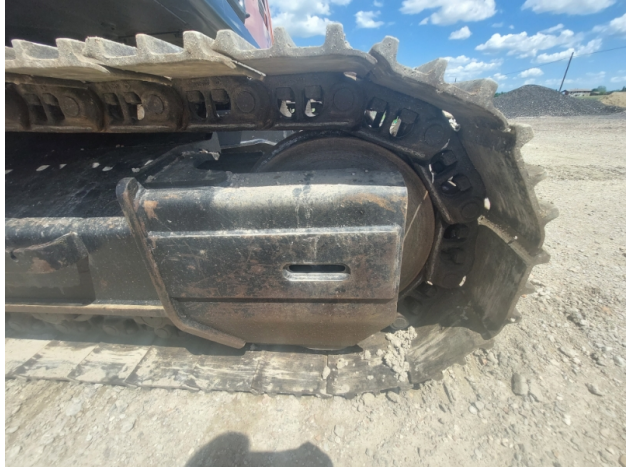
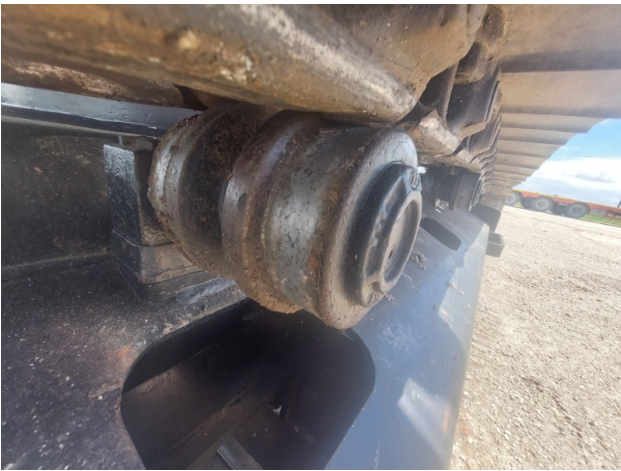
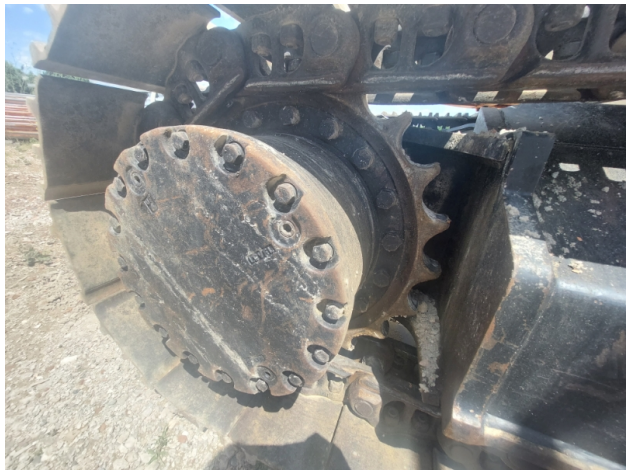
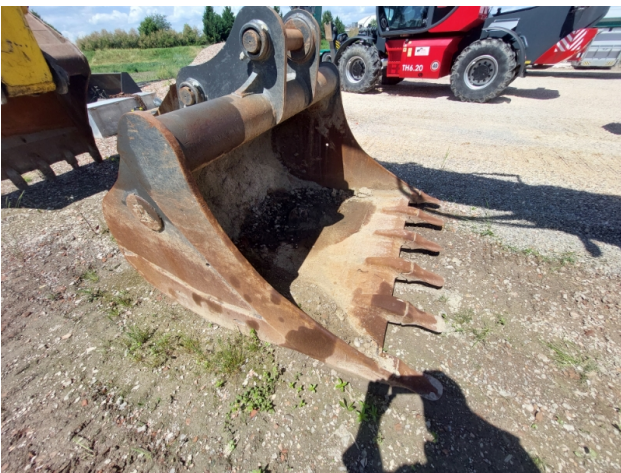
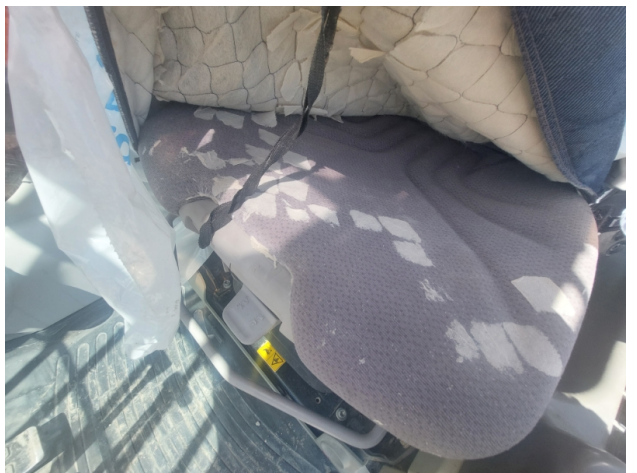
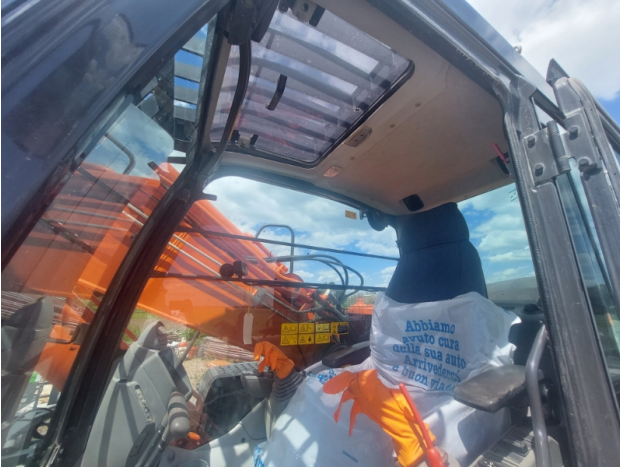
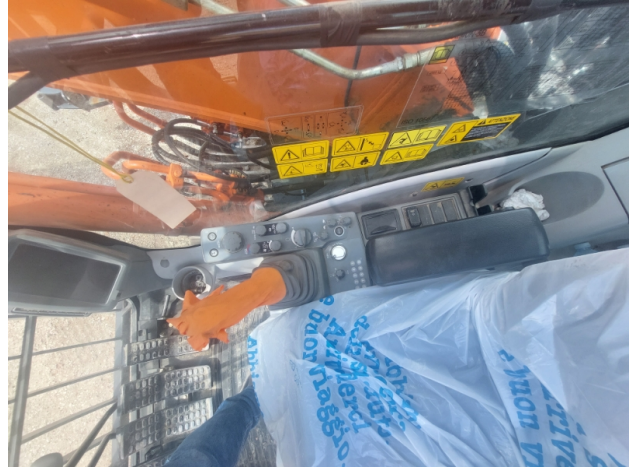
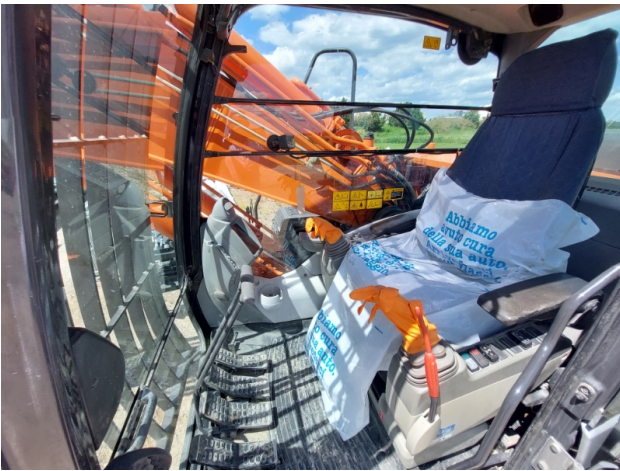
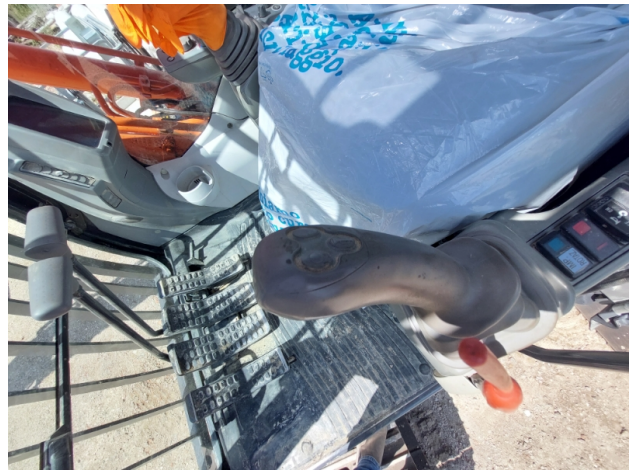
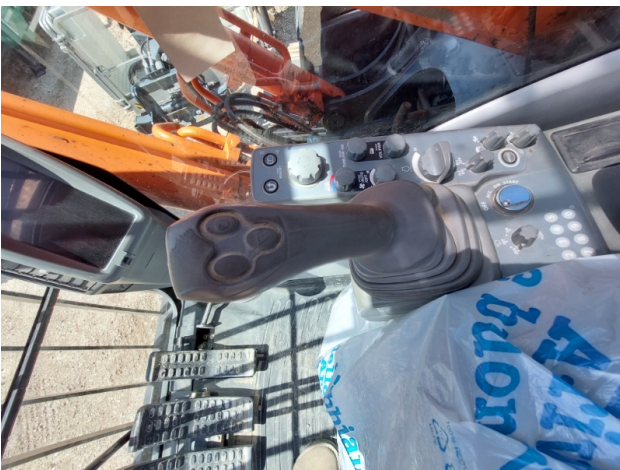
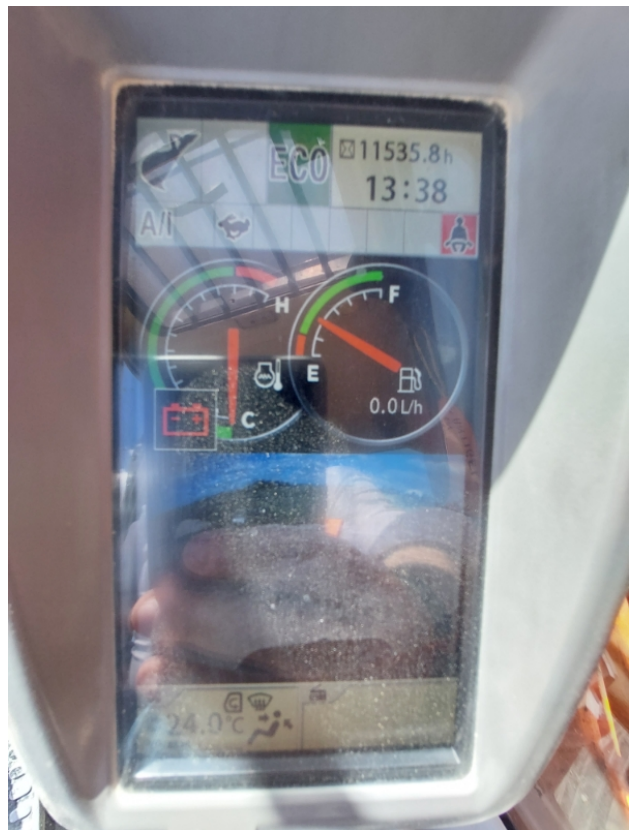
MACHINE PHOTOS

- ◆ Painting Conditions Very Good

- ◆ Counterweight conditions: Very good

- ◆ Frame/Bumper conditions: Good

- ◆ Sprockets residual: 35

- ◆ Front idler wheel residual: 35

- ◆ Rollers upper/bottom residual: 25

- ◆ Chains residual: 25

- ◆ Bucket & Get conditions: Poor
