SALES REPORT: CATERPILLAR 323F - SN YEC10029 - Year 2017

This Report is a summary about observations came out from technical inspection done by our specialised technician.

Model: 323F

Serial Number: YEC10029

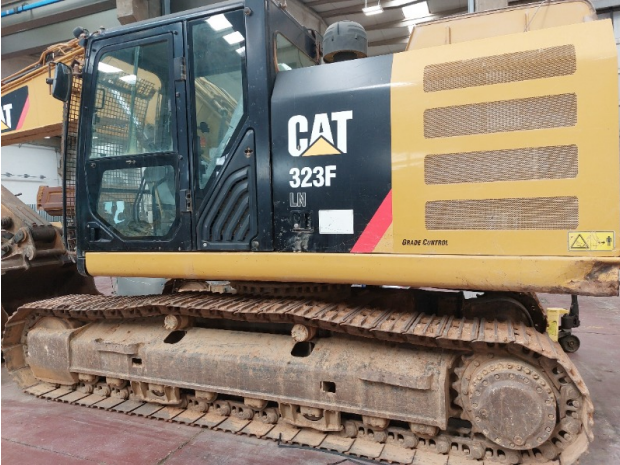
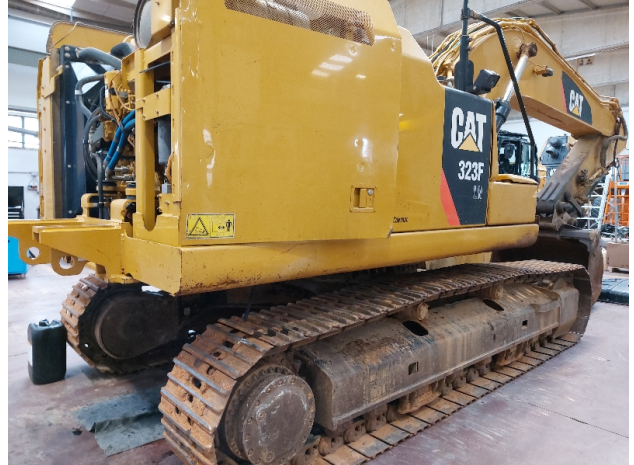
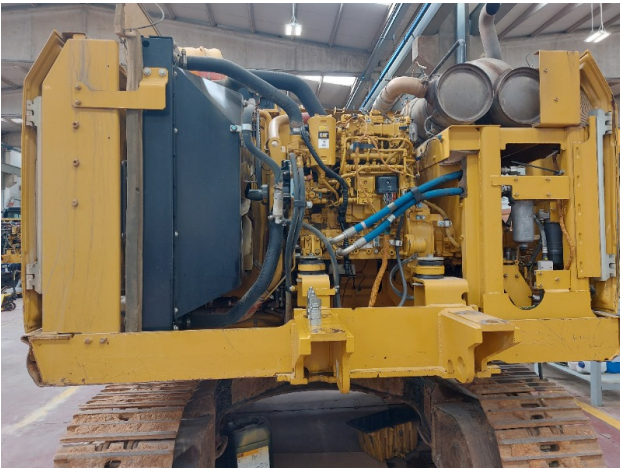
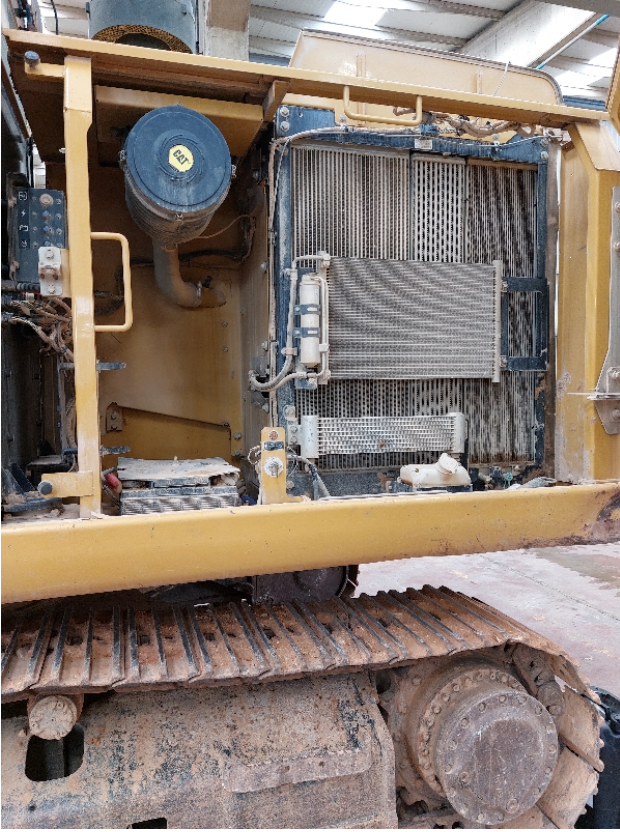
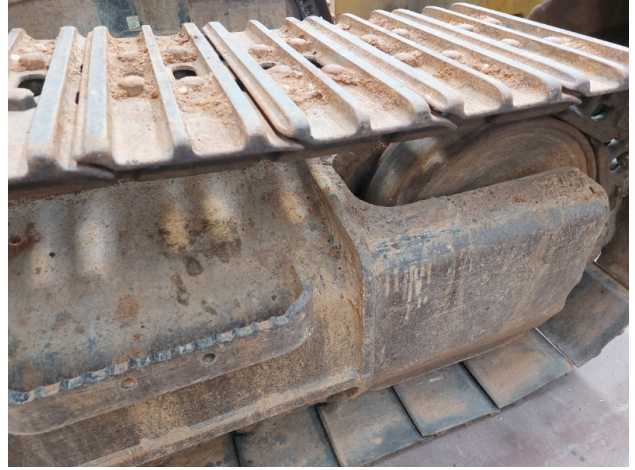
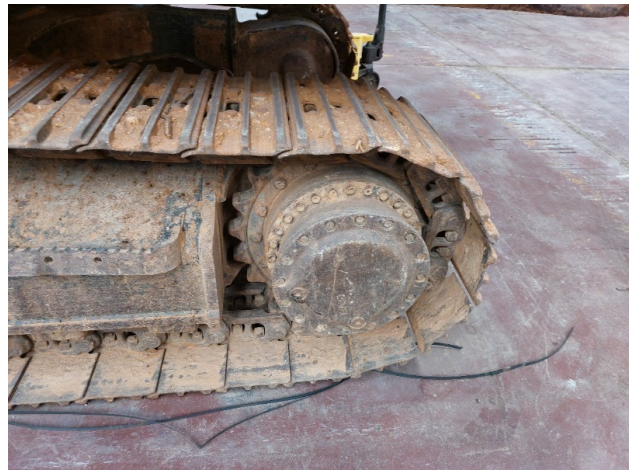
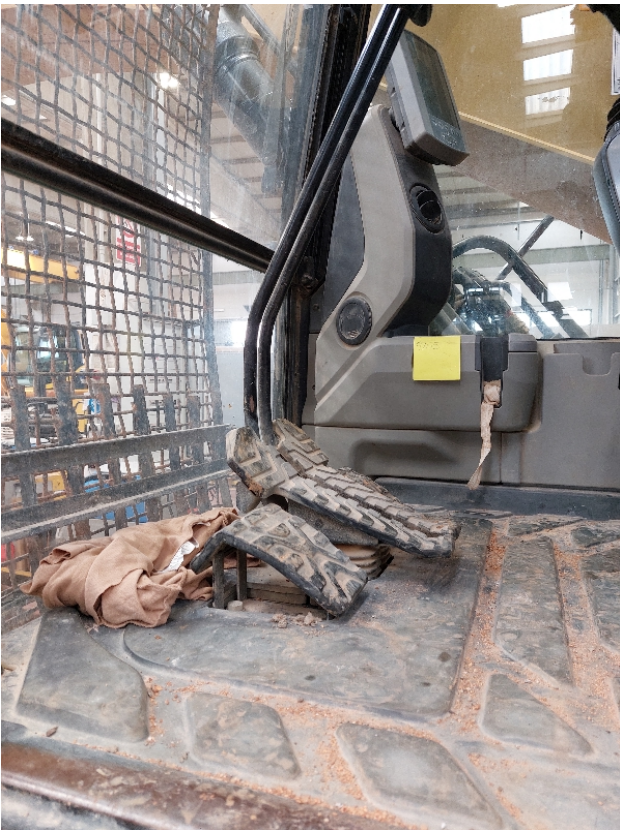
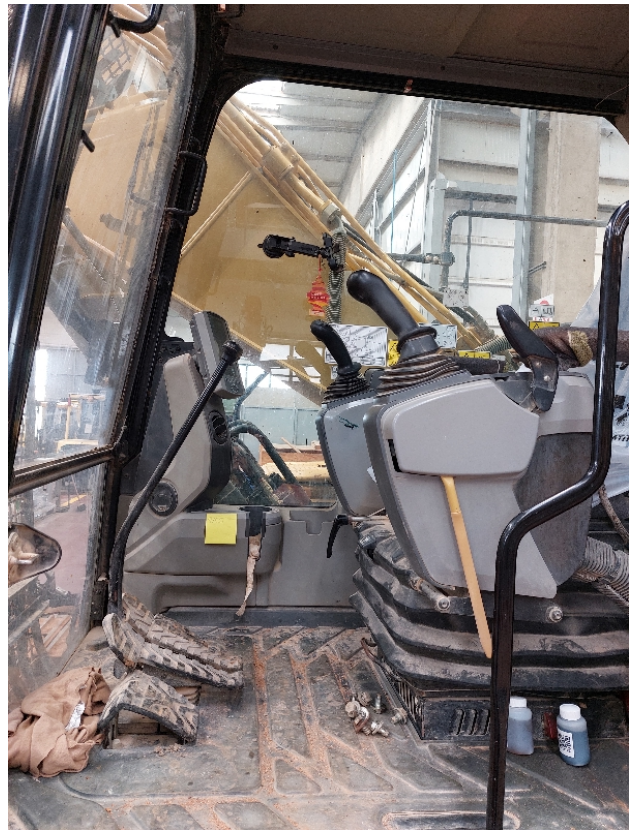
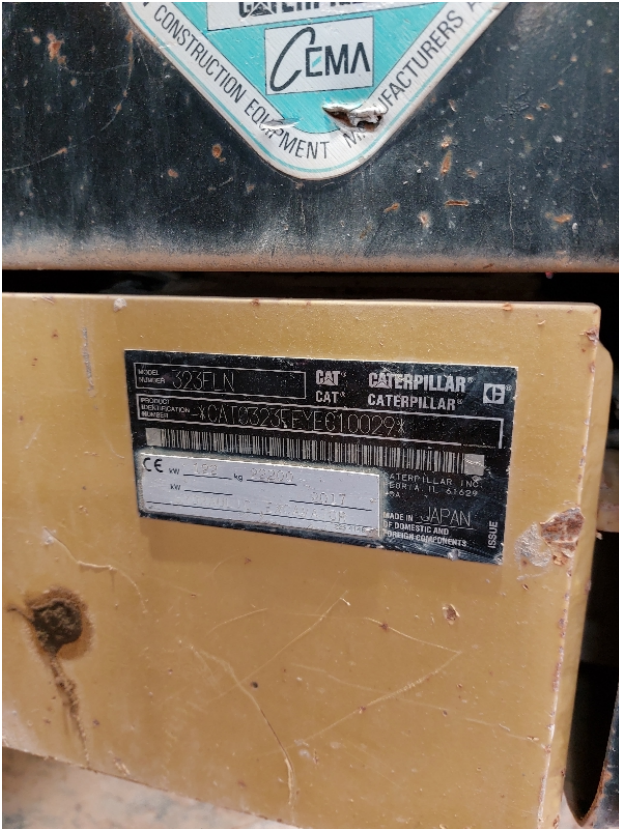
MACHINE PHOTOS

◆ Painting Conditions	Poor
<hr/>	
◆ Counterweight conditions:	Good
<hr/>	
◆ Frame/Bumper conditions:	Good

◆ Sprockets residual:	50
<hr/>	
◆ Front idler wheel residual:	50
<hr/>	
◆ Rollers upper/bottom residual:	50
<hr/>	
◆ Chains residual:	50

- ◆ Door conditions (right): Poor

- ◆ Spar conditions (left): Poor

- ◆ Engine working conditions: Not working

- ◆ Engine with oil leaks: No
If Yes, where : macchina in off.na con rottura motore - prev. € 20.000.

◆ Hydraulic joint conditions: Poor

Presence of leaks : Yes

- ◆ Pins & Bushings boom conditions: Poor

- ◆ Pins & Bushings stick conditions: Poor

- ◆ Pins & Bushings bucket conditions: Poor

- ◆ Bucket & Get conditions: Poor

- ◆ Rear view mirrors conditions: Broken or Chipped - needs repair

◆ Stepladders & handrails conditions:	Poor
◆ Cameras conditions:	Excellent - no needs repair
◆ Flashing conditions:	Not functioning
◆ Safety belt conditions:	Present and expired
◆ Controls been modified:	No
◆ Presence of Exclusion Control Lever:	Yes
◆ Are Tools Functional & Visible with tag:	Yes
◆ Canopy completed and comes with keys and bolt:	Yes
◆ All Pipes with no damage e/o scratches:	Yes
◆ Batteries box shielded:	Yes
◆ Acoustic alarm works properly:	Yes
◆ Boardwalk presence:	Present and functioning
