SALES REPORT: KOMATSU PC450#KKOMA - SN K15### - Year 2006

This Report is a summary about observations came out from technical inspection done by our specialised technician.

Model: PC450#KKOMA

Serial Number: K15###

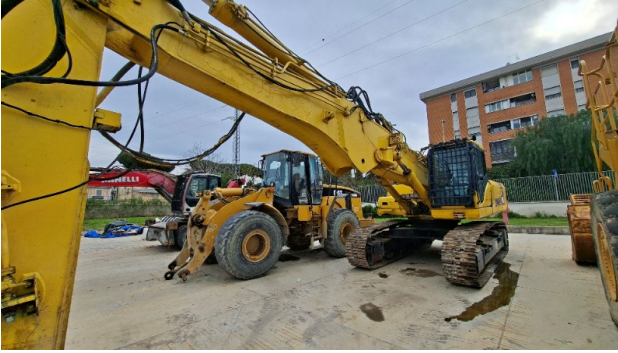
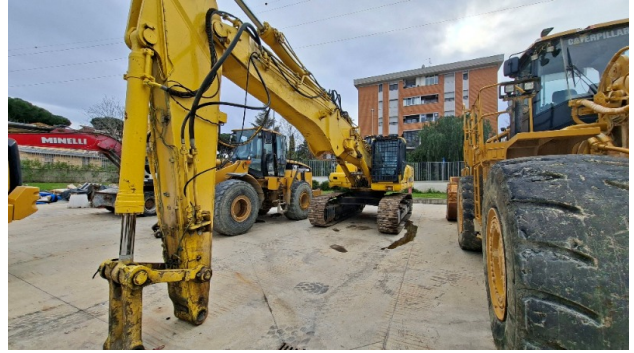
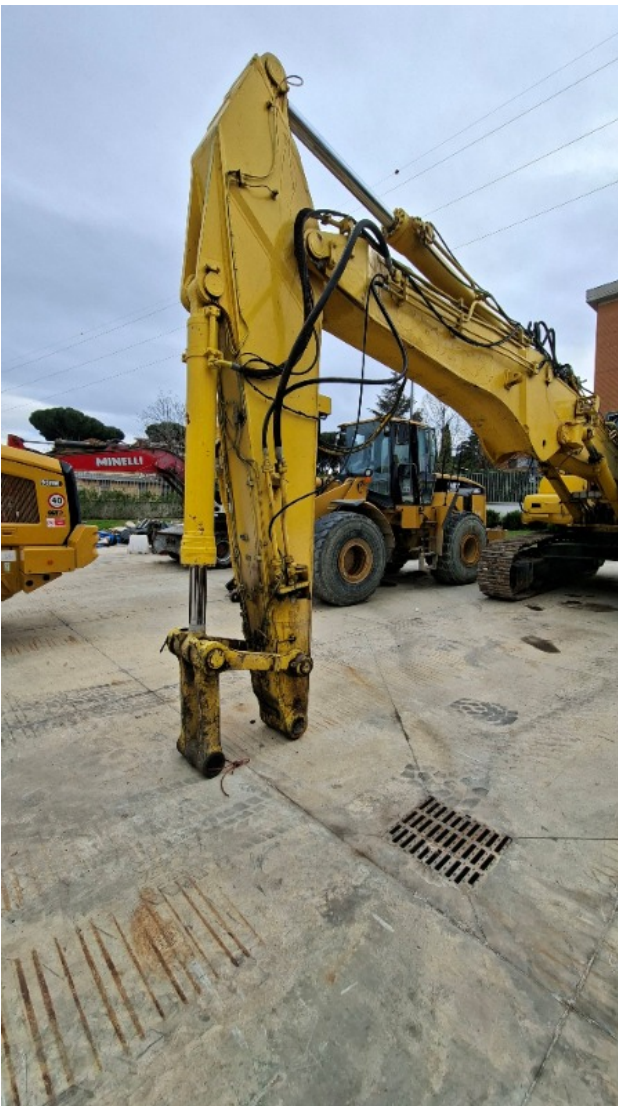
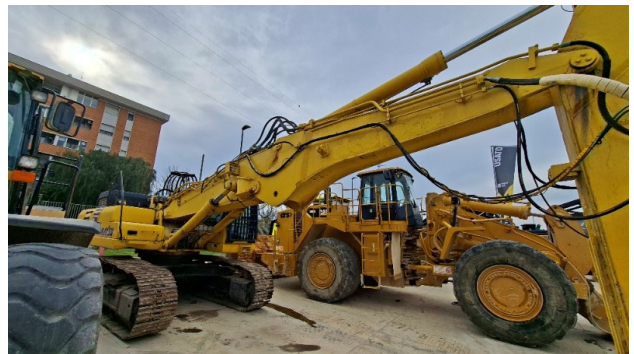
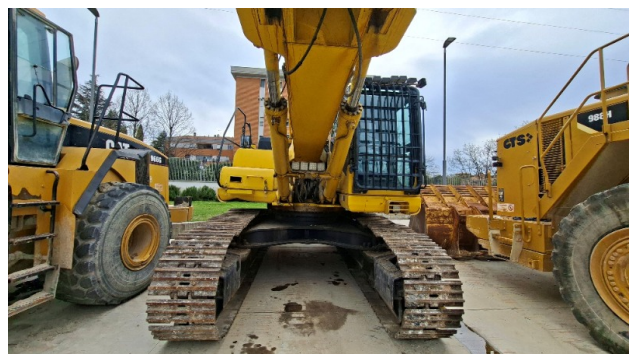
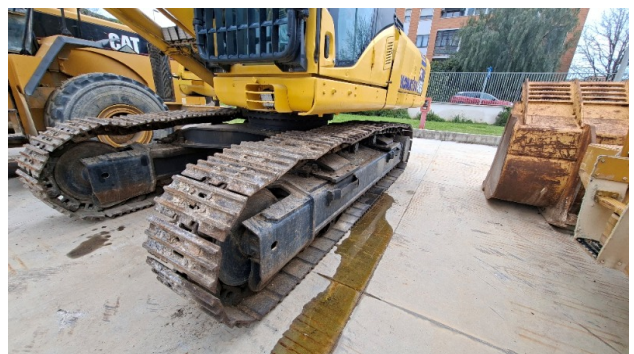
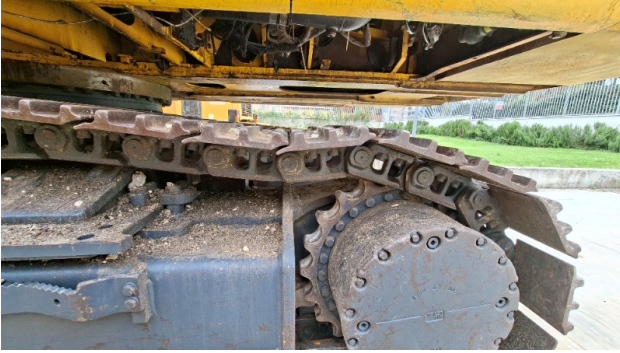
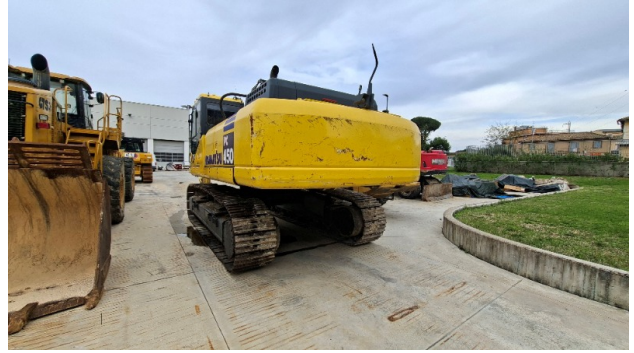
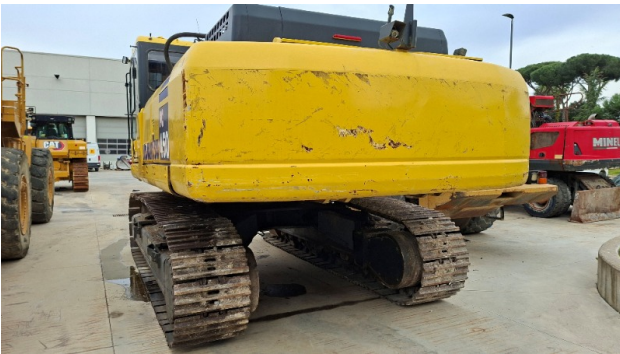
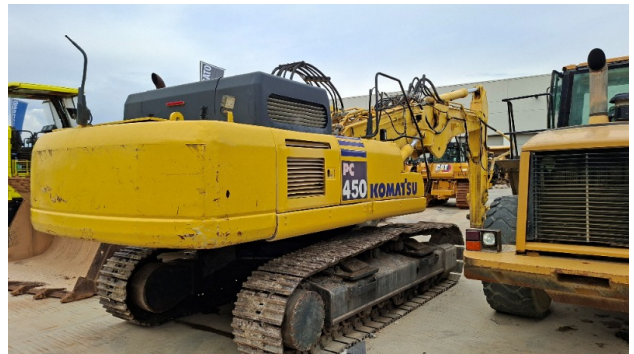
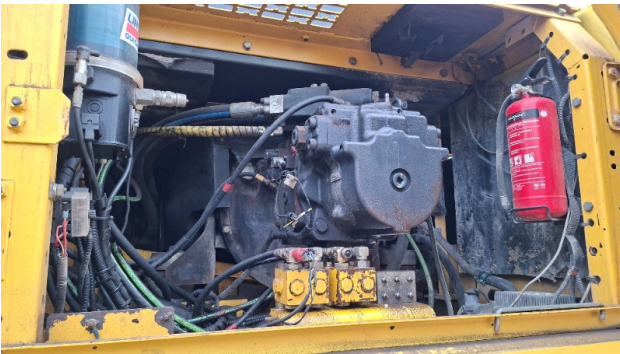
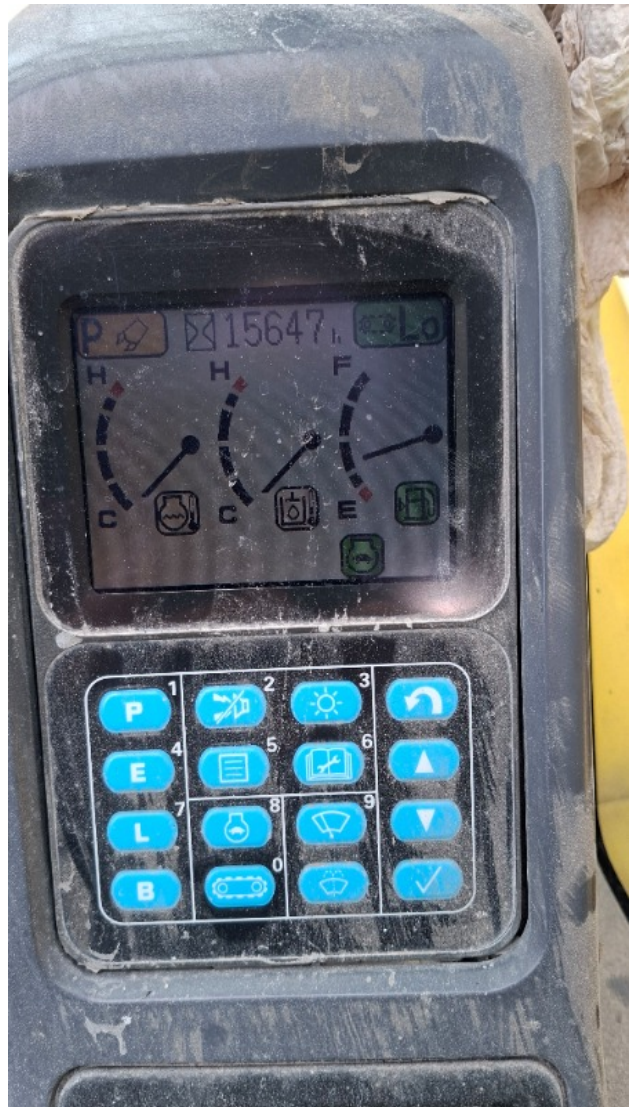
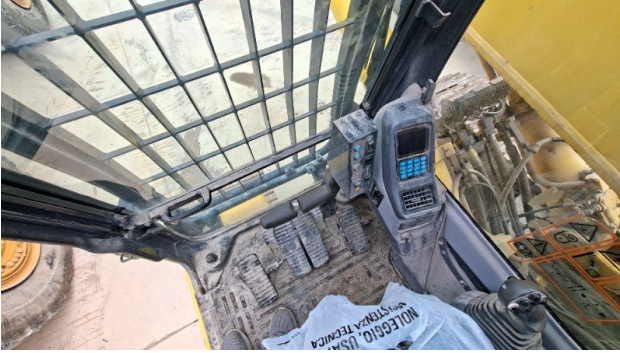
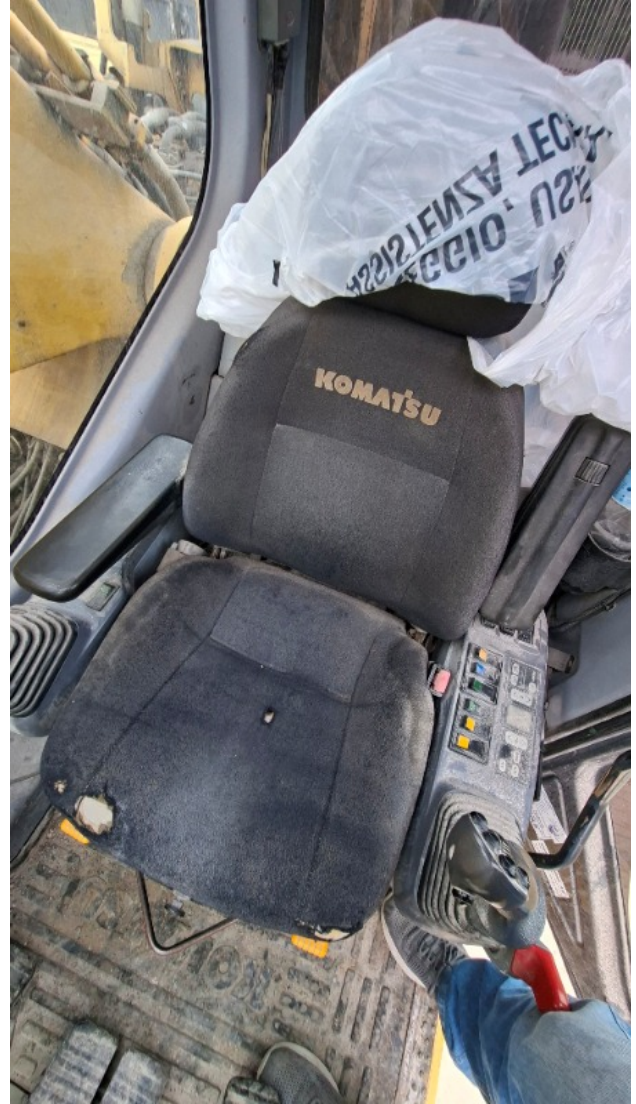
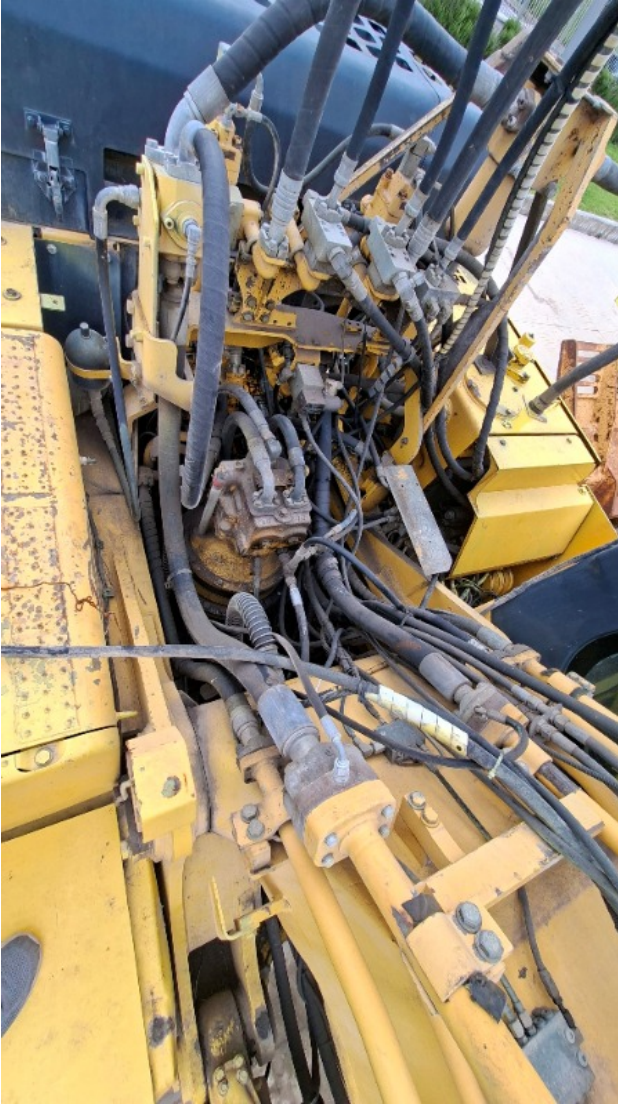
MACHINE PHOTOS

◆ Painting Conditions	Poor
◆ Counterweight conditions:	Poor
◆ Frame/Bumper conditions:	Good

◆ Sprockets residual:	30
◆ Front idler wheel residual:	40

◆ Rollers upper/bottom residual: 30

◆ Chains residual: 40

◆ Door conditions (right): Poor

◆ Spar conditions: Poor

◆ Other issues: DIVERSI GRAFFI

◆ Door conditions (left): Poor

◆ Spar conditions (left): Poor

◆ Hood/Armor bottom conditions: Present and bash

◆ Flexible pipes conditions:	Poor
◆ Boom cylinders conditions:	Poor Leaks : Yes
◆ Stick cylinder conditions:	Poor Leaks : Yes
◆ Bucket cylinder conditions:	Poor Leaks : Yes
◆ Pins & Bushings boom conditions:	Poor
◆ Pins & Bushings stick conditions:	Good
◆ Pins & Bushings bucket conditions:	Poor
◆ Bucket & Get conditions:	Good
◆ Quick Coupler conditions:	NA - Not applicable
◆ Auto Lube working conditions:	No

◆ Conditions internal cabin:	Poor
	Other notes : SEDILE DA SISTEMARE
◆ Flashing presents issues:	No
◆ Lights & Windshield present issues:	Present and not functioning
◆ Air conditioning is working:	Presente e funzionante
◆ Back & side camera conditions:	Not functioning

◆ Glass conditions:	Excellent - no needs repair
◆ Lights conditions:	Broken or Chipped - needs repair
◆ Rear view mirrors conditions:	Broken or Chipped - needs repair
◆ Stepladders & handrails conditions:	Good
◆ Cameras conditions:	Broken or Chipped - needs repair
◆ Flashing conditions:	Not functioning
◆ Safety belt conditions:	Not present/Broken
◆ Controls been modified:	No
◆ Presence of Exclusion Control Lever:	Yes
◆ Are Tools Functional & Visible with tag:	Yes
◆ Canopy completed and comes with keys and bolt:	No
◆ All Pipes with no damage e/o scratches:	No
◆ Batteries box shielded:	Yes
◆ Acoustic alarm works properly:	Yes
◆ Boardwalk presence:	Not present
