SALES REPORT: KOMATSU PC16R-3#KKOMA - SN F71### - Year 2011

This Report is a summary about observations came out from technical inspection done by our specialised technician.

Model: PC16R-3#KKOMA

Family: MINI EXCAVATOR

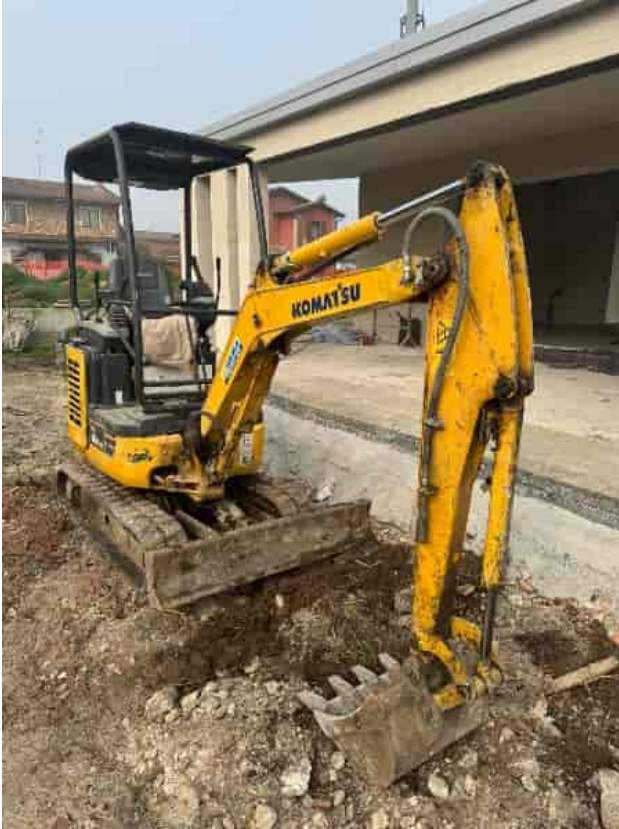
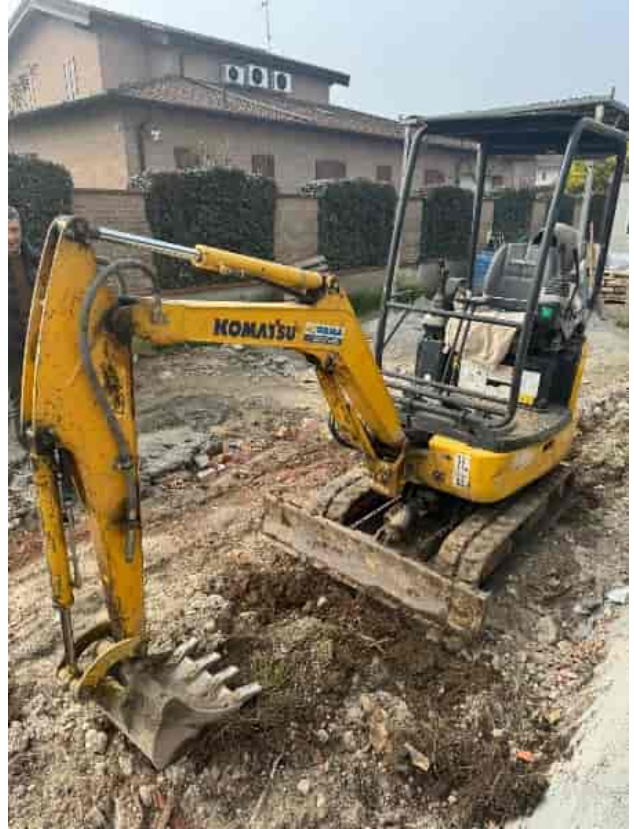
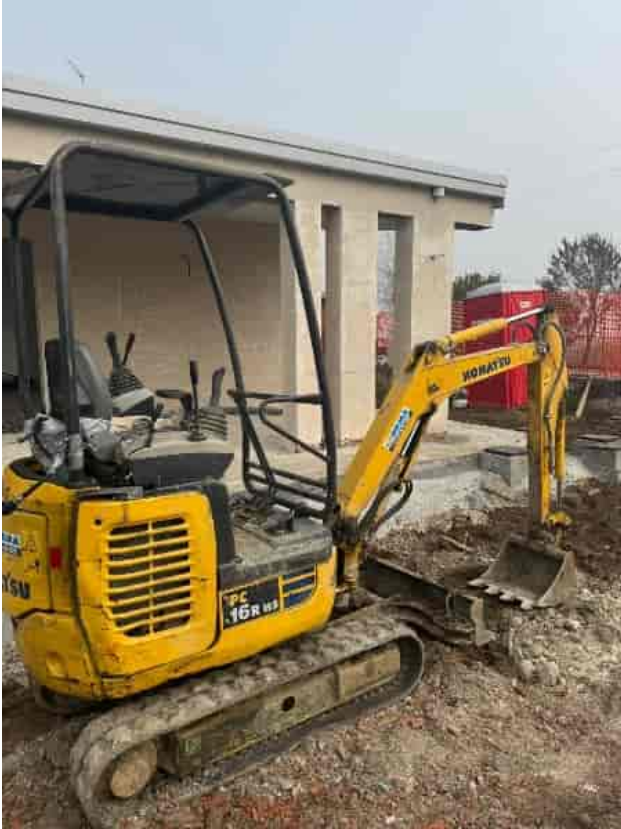
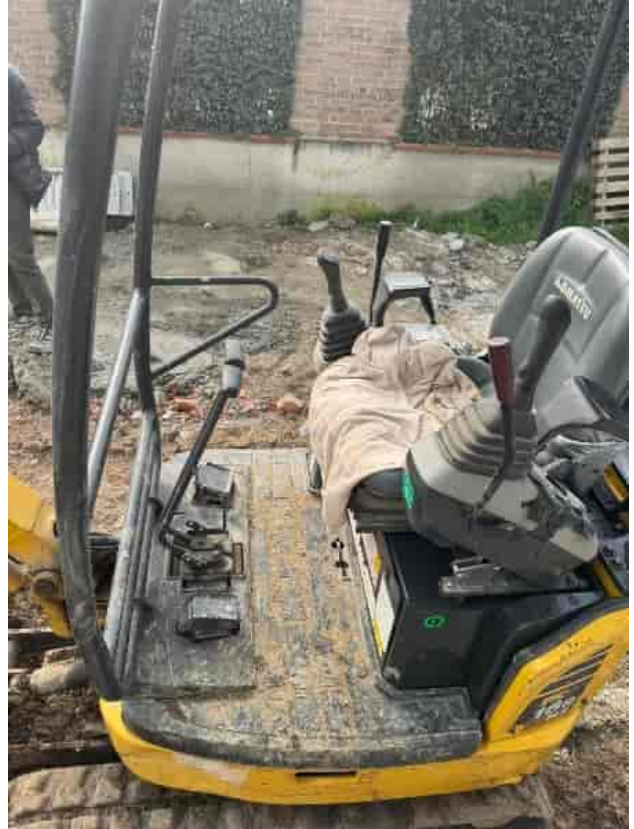
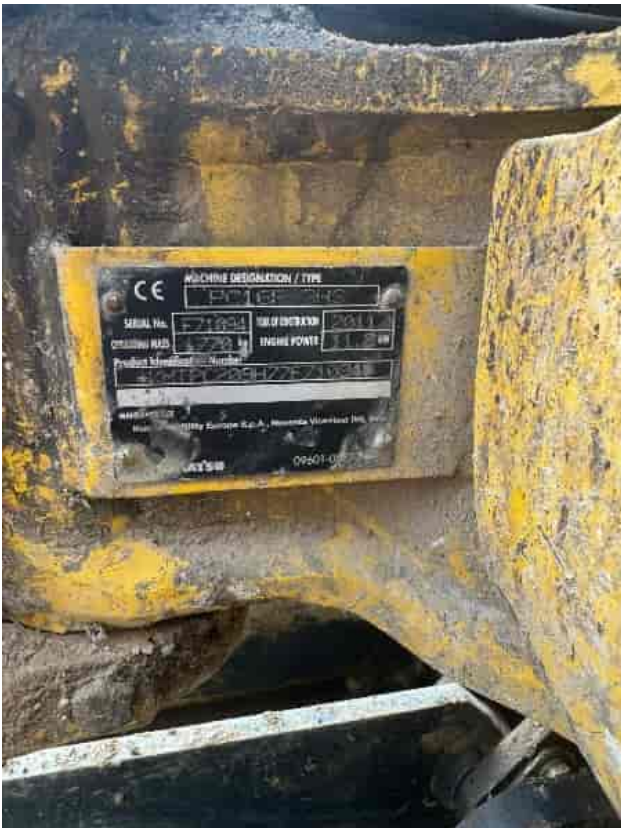
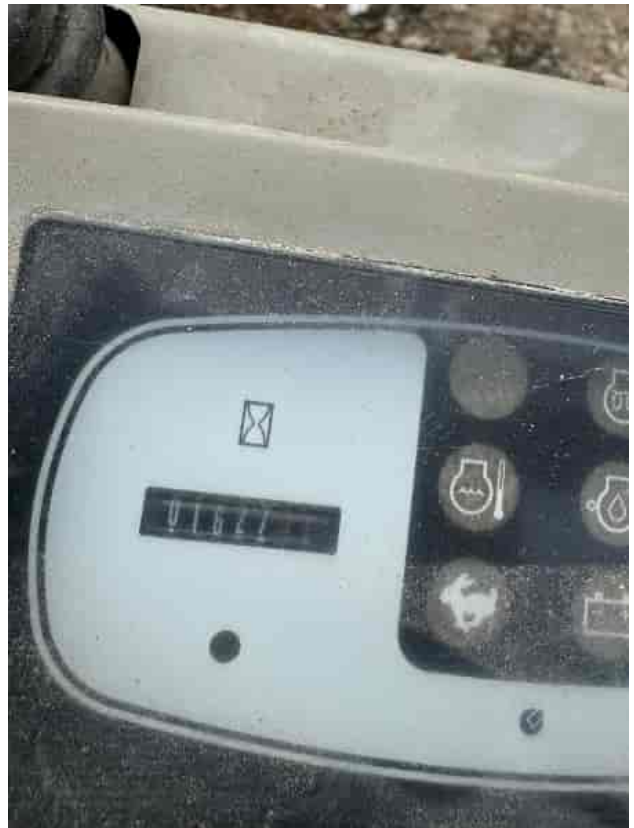
MACHINE PHOTOS

◆ Painting Conditions Poor

◆ Counterweight conditions: Good

◆ Frame/Bumper conditions: Good

◆ Hood/Armor bottom conditions: Present and bash
