## SALES REPORT: CATERPILLAR 966M XE - SN DZL00580 - Year 2019

This Report is a summary about observations comes out from technical inspection done by our specialised technician.

**Model:** 966M XE

**Serial Number:** DZL00580

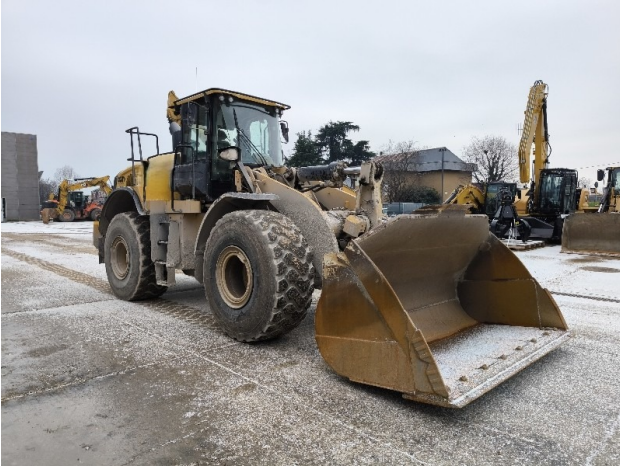
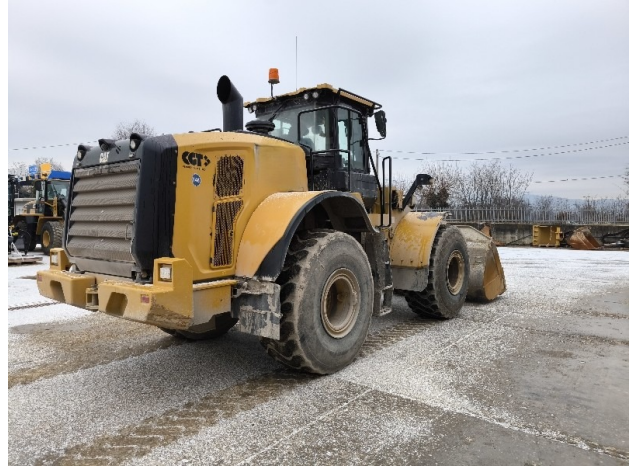
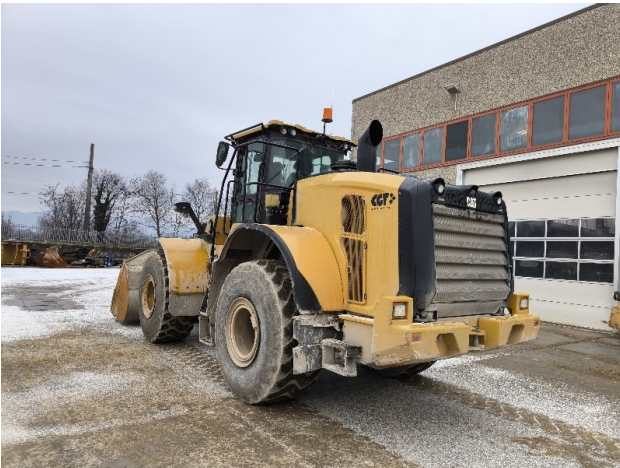
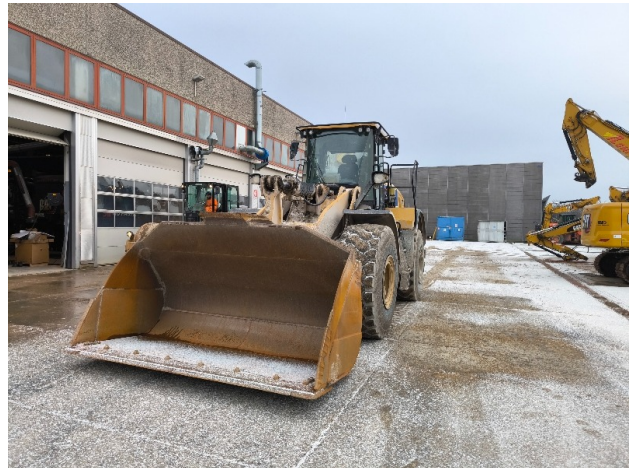
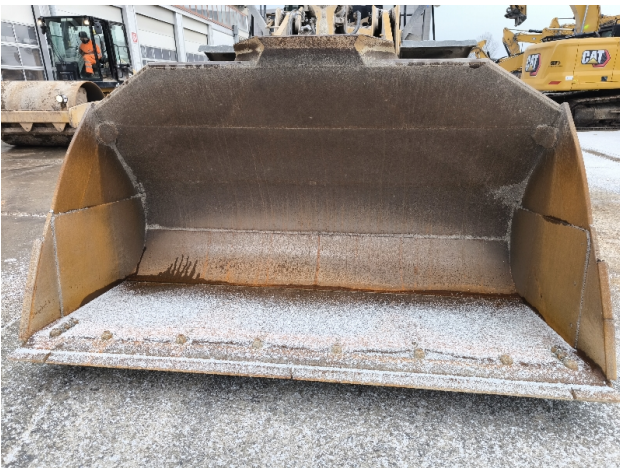
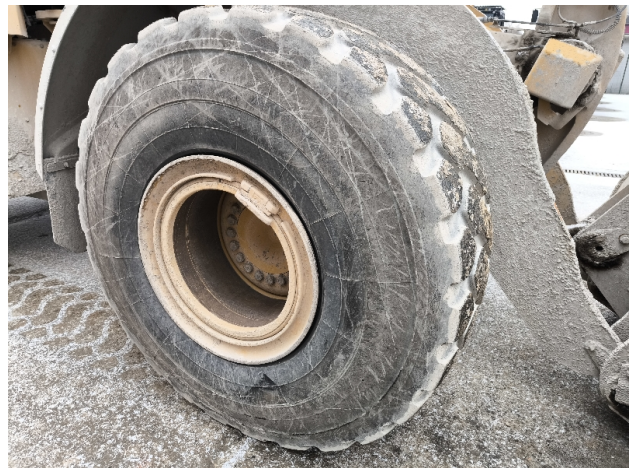
**MACHINE PHOTOS**

- ◆ Door conditions: Poor

- ◆ Other notes: Vetro anteriore dx,centrale ,sx da cambiare

- ◆ Engine working conditions: Poor

- ◆ Engine travel conditions: Poor

- ◆ Hydraulic joint conditions: Poor

- ◆ Gear switches go/back conditions: Poor

- ◆ Annotazioni su: Trasmissione da revisionare
