SALES REPORT: HITACHI ZX38U-6#KHITA - SN HCMADC5ZT00052### - Year 2017

This Report is a summary about observations came out from technical inspection done by our specialised technician.

Model: ZX38U-6#KHITA

Family: MINI EXCAVATOR

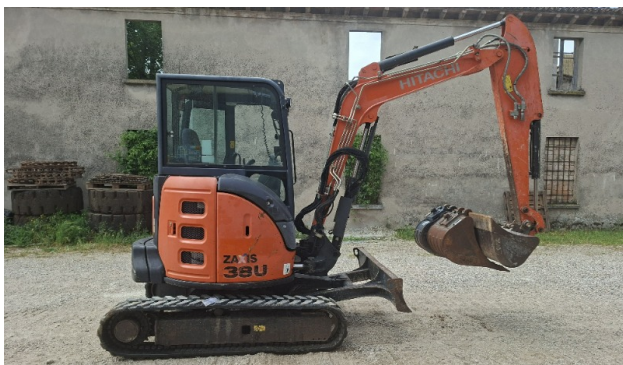
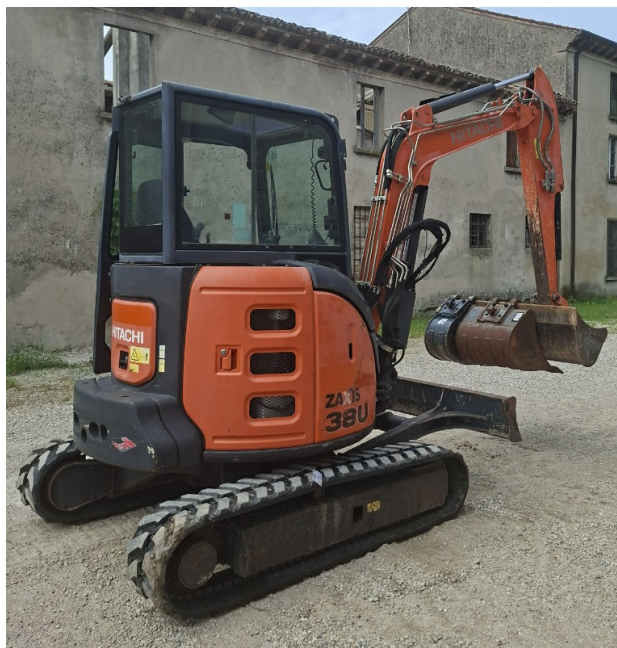
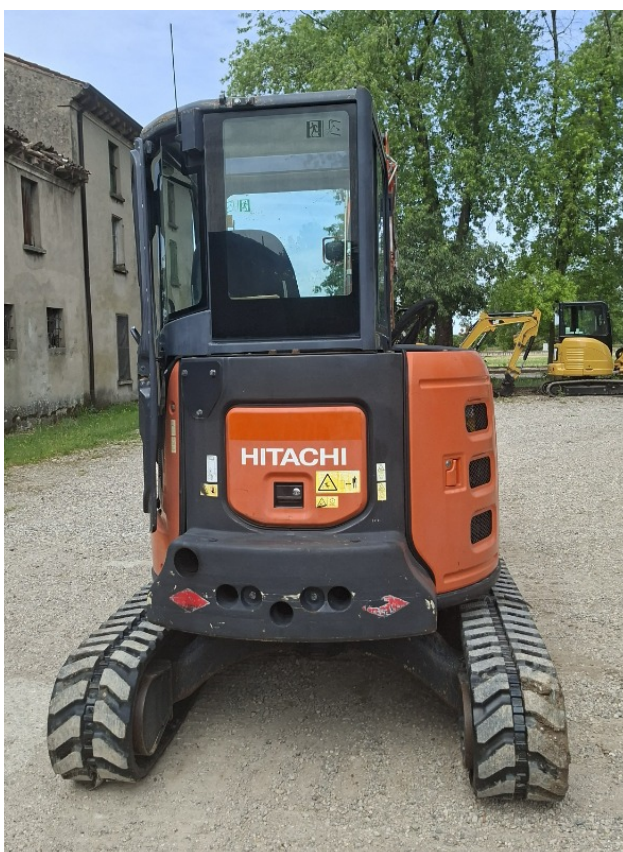
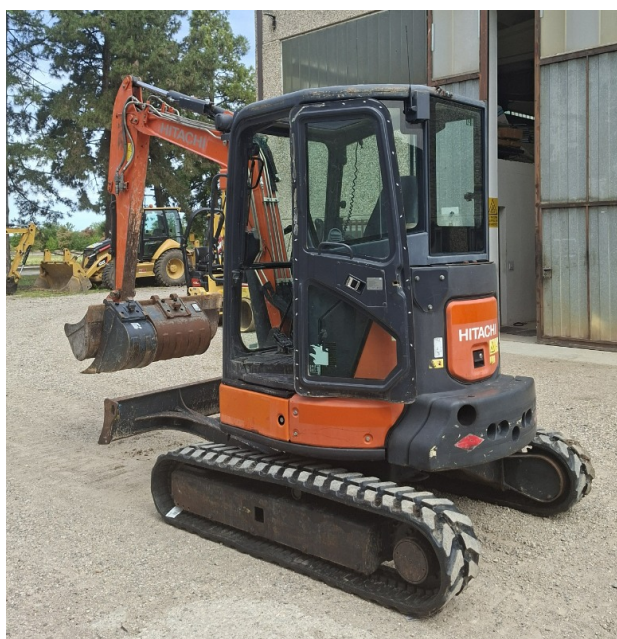
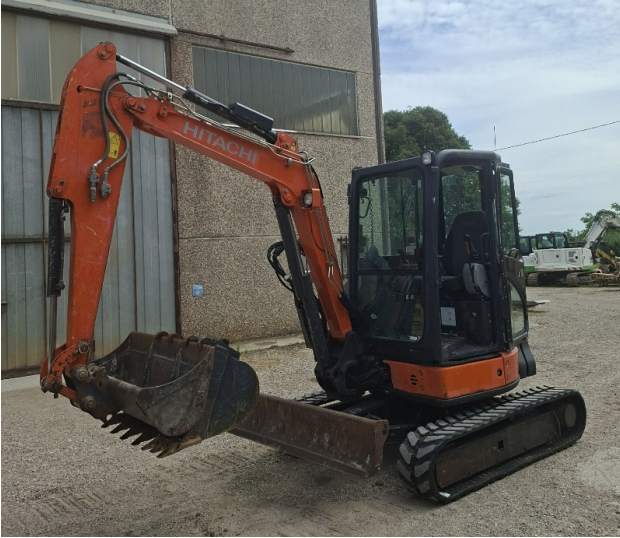
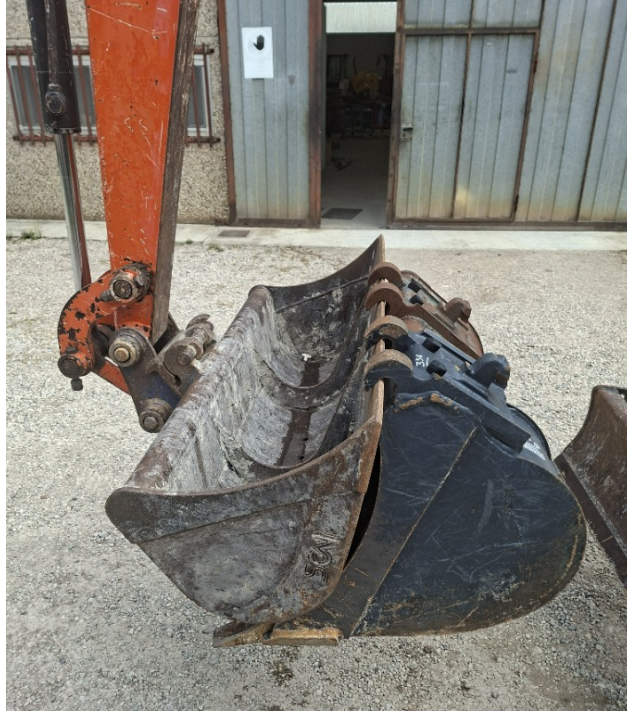
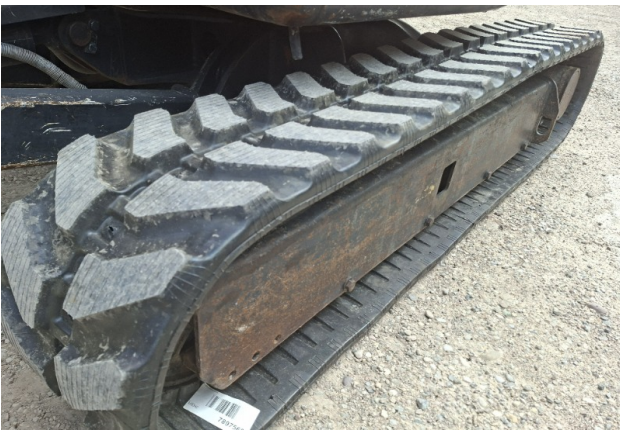
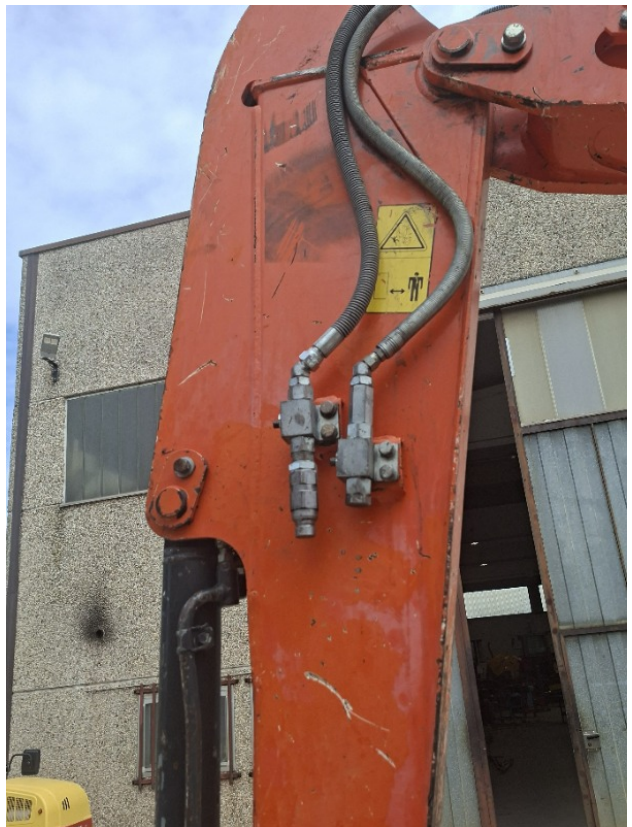
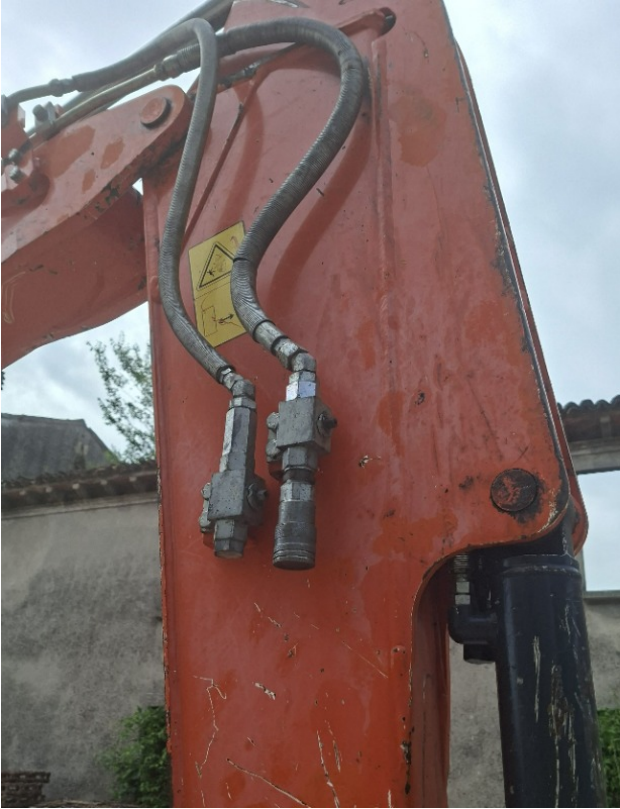
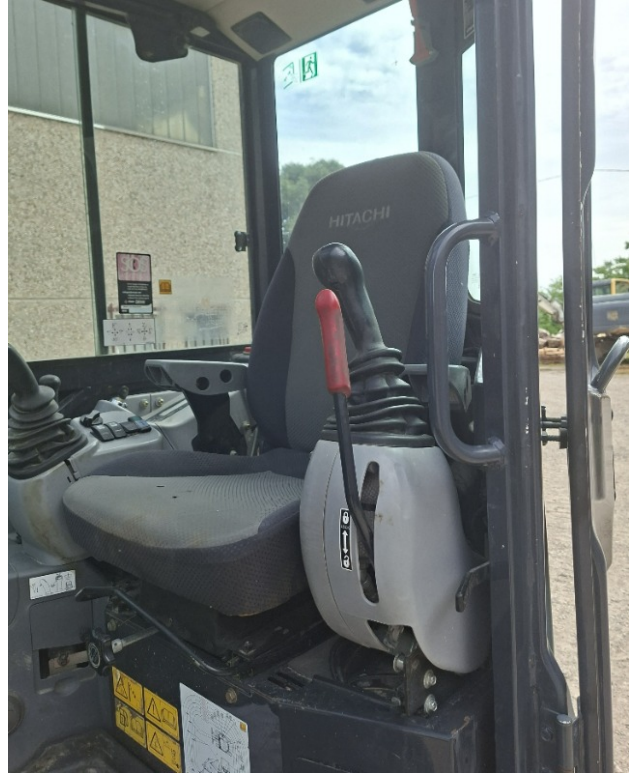
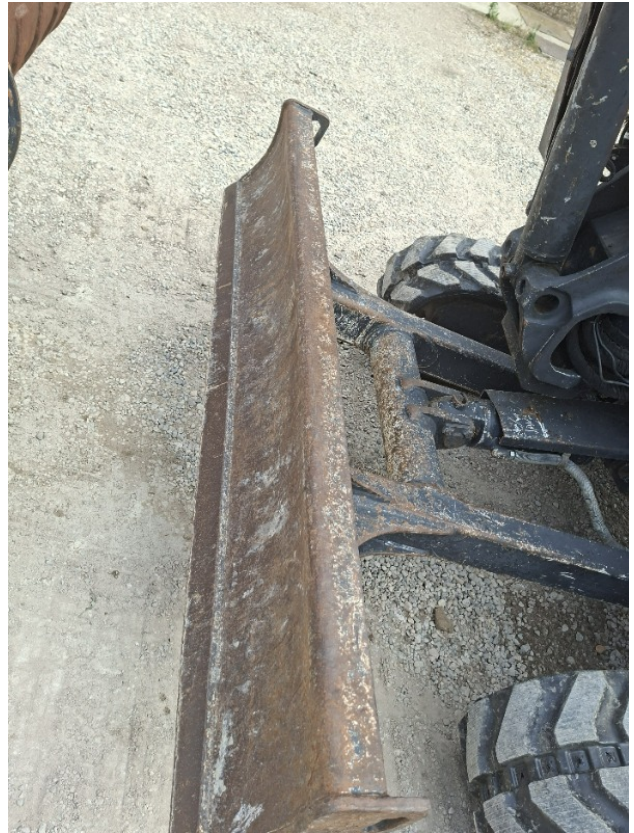
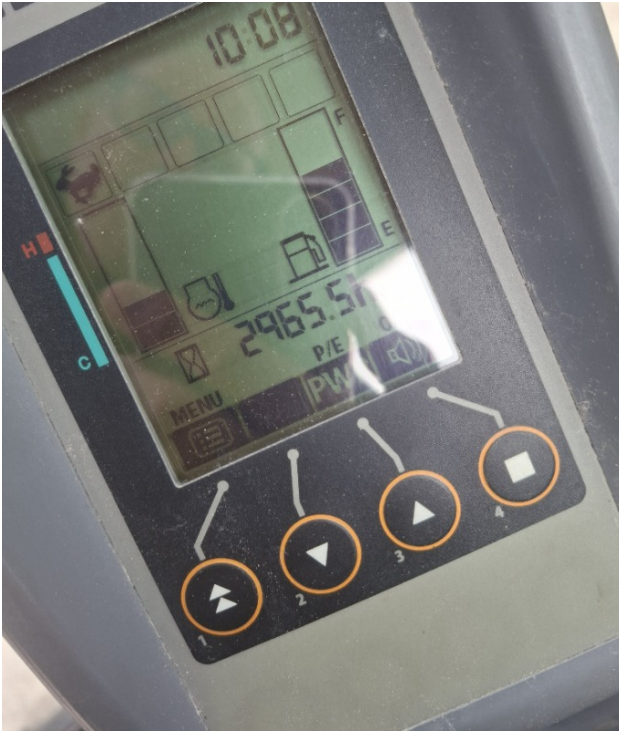
MACHINE PHOTOS

◆ Painting Conditions	Good
<hr/>	
◆ Counterweight conditions:	Good
<hr/>	
◆ Frame/Bumper conditions:	Good

◆ Sprockets residual:	60
<hr/>	
◆ Front idler wheel residual:	60
<hr/>	
◆ Rollers upper/bottom residual:	60
<hr/>	
◆ Chains residual:	100

◆ Hood/Armor bottom conditions: Present and bash

◆ Batteries/Cables conditions: Poor

◆ Presence of electrical fault: Si

- ◆ Pins & Bushings bucket conditions: Poor

- ◆ Quick Coupler conditions: Not working

- ◆ Lights conditions: Broken or Chipped - needs repair

- ◆ Rear view mirrors conditions: Broken or Chipped - needs repair

- ◆ Cameras conditions: Broken or Chipped - needs repair
