SALES REPORT: CATERPILLAR 323SA - SN KPE20357 - Year 2022

This Report is a summary about observations cames out from technical inspection done by our specialised technician.

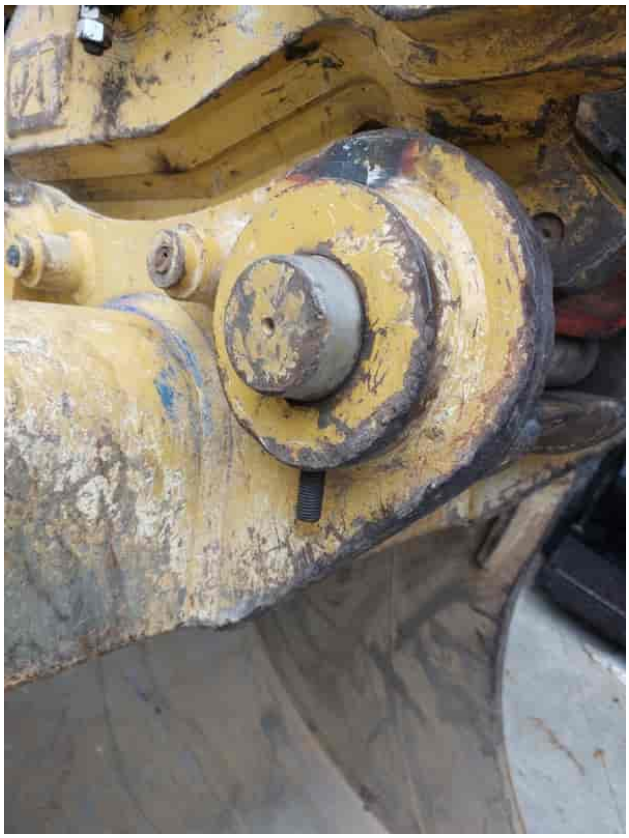
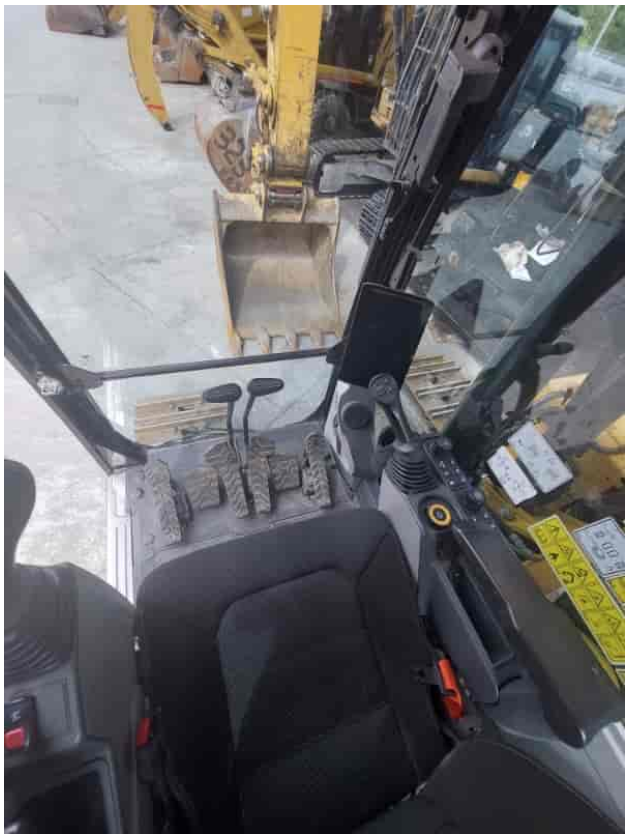
MACHINE PHOTOS

Painting Conditions	Very Good
Counterweight conditions:	Very good
Frame/Bumper conditions:	Very Good

Conditions internal cabin:	Very good
Flashing presents issues:	Yes
Lights & Windshield present issues:	Presents and functioning
Air conditioning is working:	Presente e funzionante
Back & side camera conditions:	Present and functioning
