SALES REPORT: SANDVIK QJ341 - SN QJ341-10053 - Year 2018

This Report is a summary about observations cames out from technical inspection done by our specialised technician.

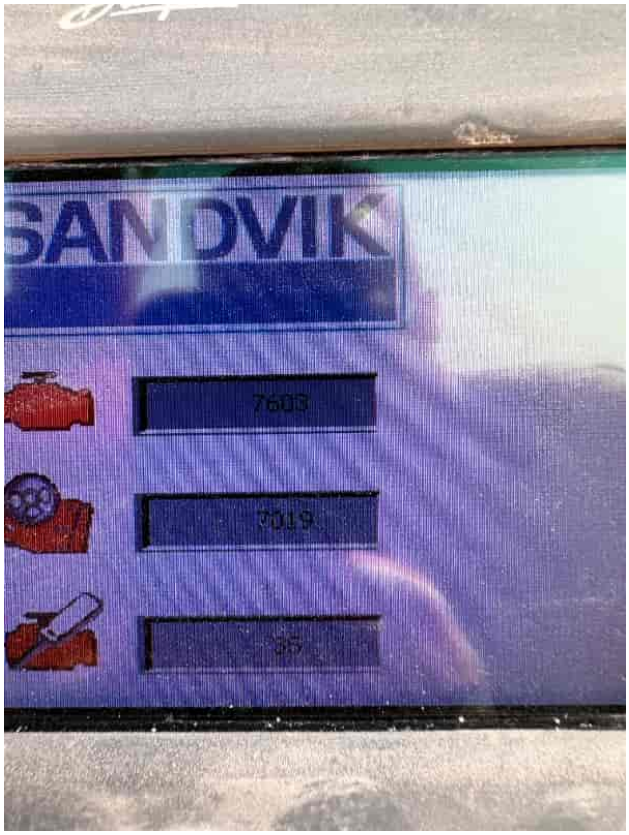
- Il contaore e': Funzionante

SANDVIK
CE
SANDVIK
2018 MODEL
ARRESTO DI EMERGENZA
