SALES REPORT: CATERPILLAR AP600F - SN AP600166 - Year 2018

This Report is a summary about observations cames out from technical inspection done by our specialised technician.

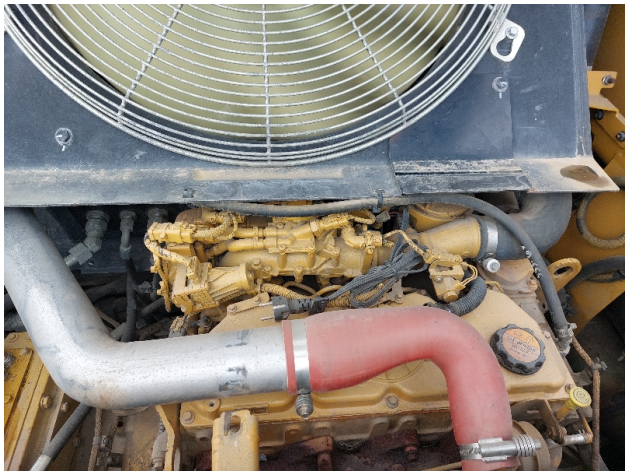
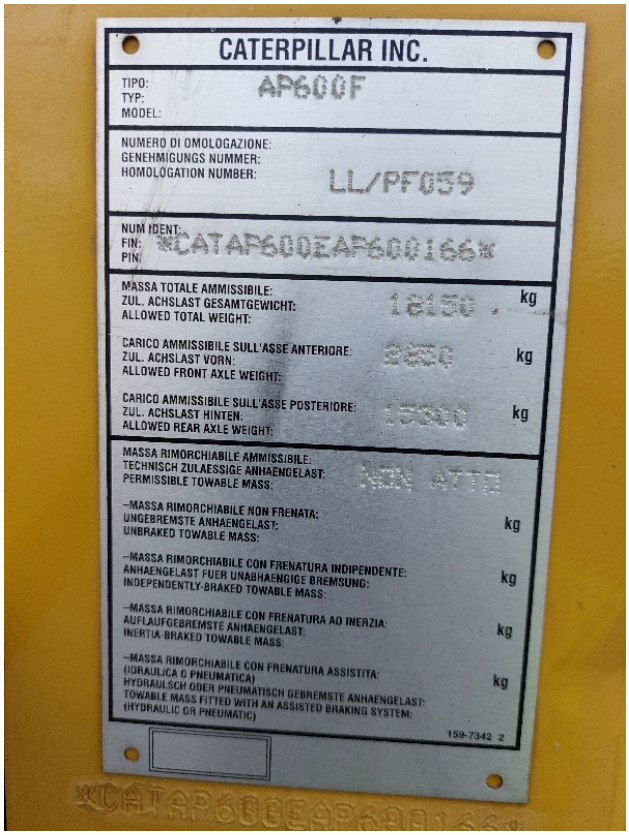
MACHINE PHOTOS

Painting Conditions	Good
Spar conditions:	Good
Residual % - Tyres/Track:	40
Residual % - Cushion:	70
Seat condition:	Poor
Engine working conditions:	Good
Radiator conditions:	Good
Batteries/Cables conditions:	Good

note
Paratie in gomma delle tramogge da da sostituire. Lavori su banco eseguiti tamper nuovi e altri come da foto fattura allegata
Ad ore 4945

In quale stato è stata visionata la macchina:	Accesa e funzionante "al lavoro"
Engine working conditions:	Good
Engine with oil leaks:	Yes
If Yes, where :	Piccolo trasudamento
Engine presents blowby:	No
Engine present smokiness:	No
Radiator conditions:	Good
Starter motor conditions:	Good
Batteries/Cables conditions:	Poor
Presence of electrical fault:	SI
If present, add details :	Alcuni collegamenti da sistemare

Condizioni freni:	Buono
Condizioni freno di Stazionamento:	Buono
Lights conditions:	Excellent - no needs repair
Condizioni specchietti:	Mancanti
Stepladders & handrails conditions:	Good
Cameras conditions:	Broken or Chipped - needs repair
Flashing conditions:	Not functioning
Controls been modified:	No
Presence of Exclusion Control Lever:	Yes
	If No, are control levers protected to accidental funcionality? : No
Are Tools Functional & Visible with tag:	Yes
Canopy completed and comes with keys and bolt:	Yes
All Pipes with no damage e/o scratches:	Yes
Batteries box shielded:	Yes
Acustic alarm works properly:	Yes
Boardwalk presence:	Present and bashee

Annotazioni su: Vetri anteriori incrinati
