SALES REPORT: CATERPILLAR MH3024 - SN FB700629 - Year 2019

Model: MH3024

Serial Number: FB700629

Construction year: 2019

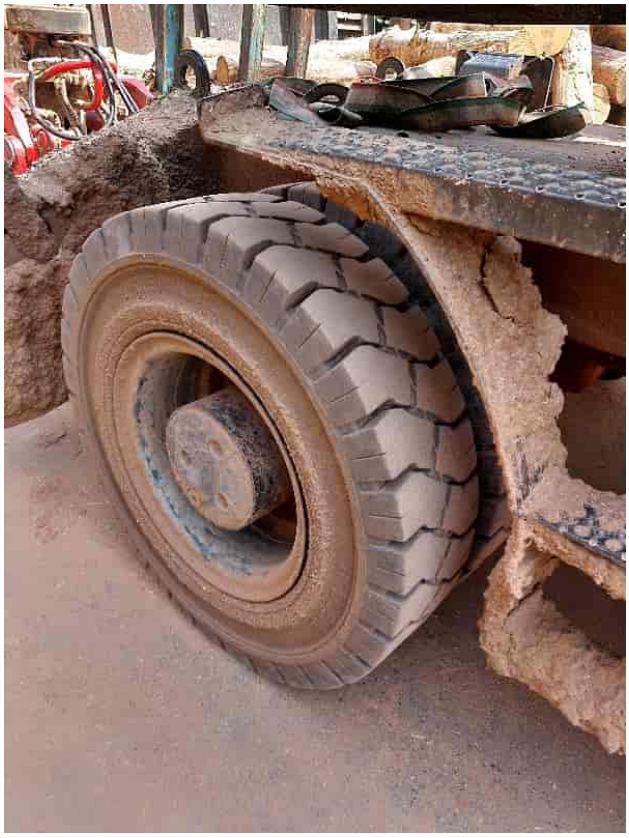
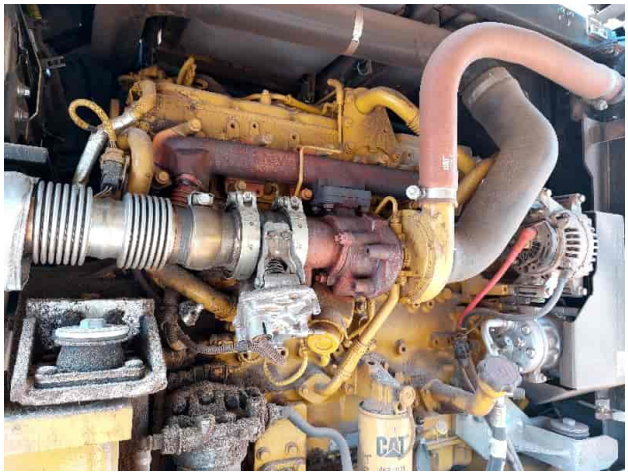
- Il contaore e': Funzionante

MODEL MH3024
BUILD 06C
CAT
CATERPILLAR
CATMH302CFB700629
CATERPILLAR INC.
PEORIA, IL 61629
USA
MADE IN FRANCE
OF DOMESTIC AND
FOREIGN COMPONENTS
ISSUE 1

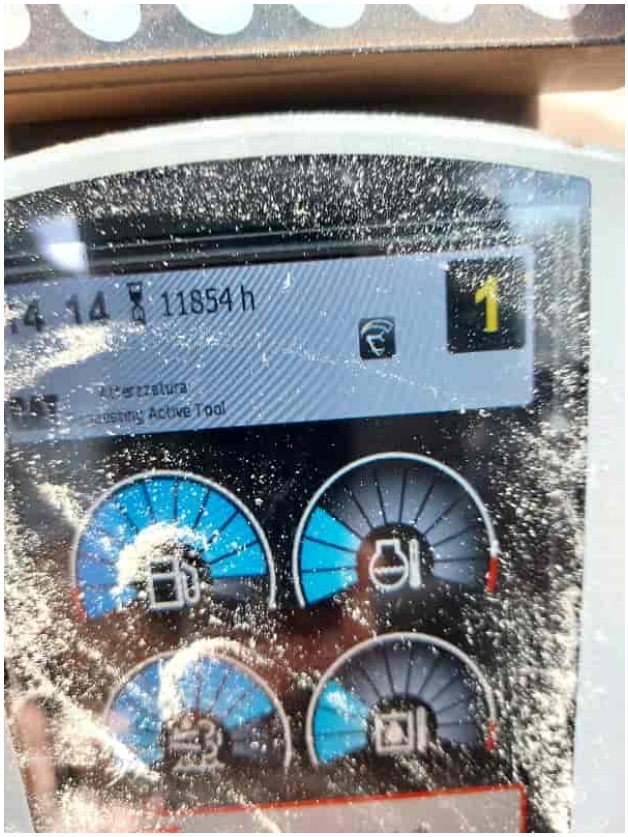
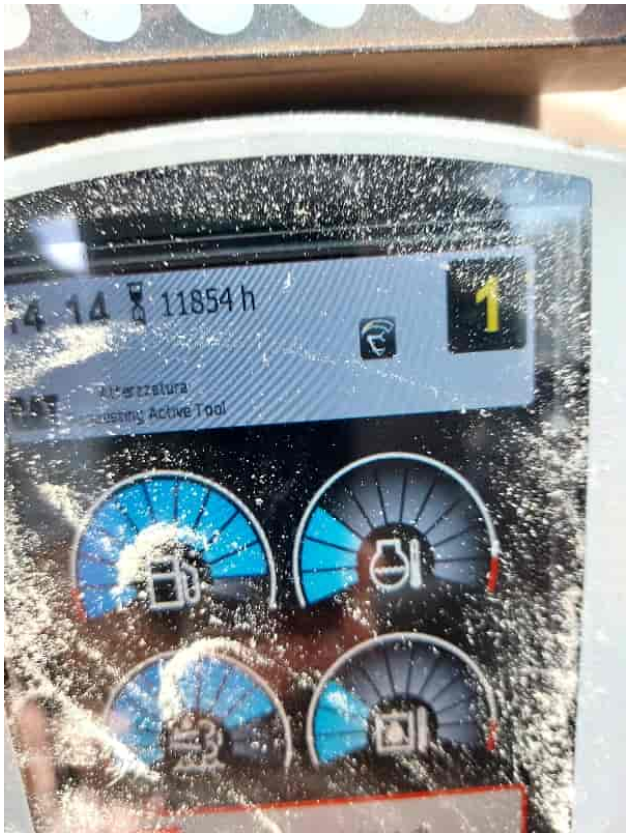
MODEL MH3024
BUILD 06C
CAT
CATERPILLAR
PRODUCT IDENTIFICATION NUMBER
CATMH302CFB700629
CATERPILLAR INC.
PEORIA, IL 61629
USA
MADE IN FRANCE
OF DOMESTIC AND
FOREIGN COMPONENTS
ISSUE 1

11854 h
1
Active Tool
