SALES REPORT: HITACHI ZW250#KHITA - SN HFL4GG00H00000130 - Year 2006

This Report is a summary about observations cames out from technical inspection done by our specialised technician.

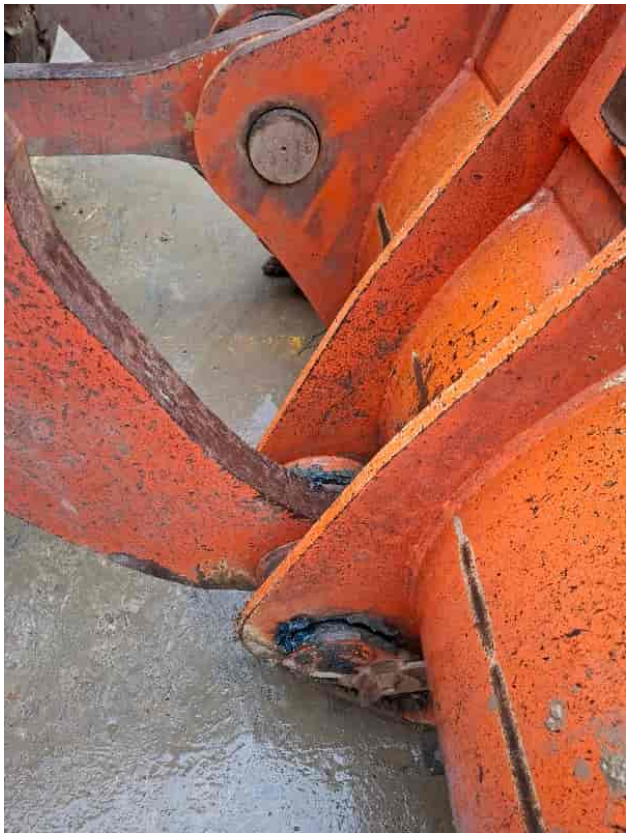
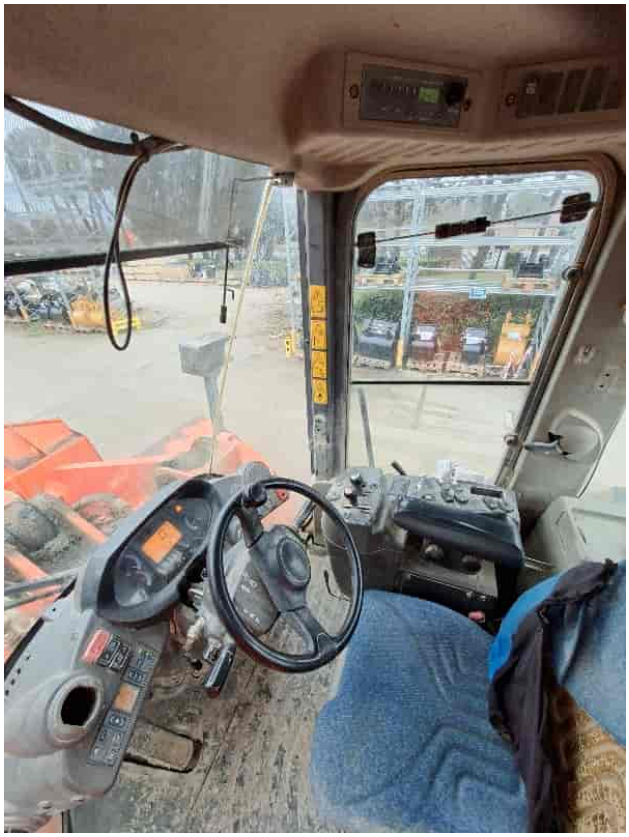
- Il contaore e': Funzionante
