SALES REPORT: VOLVO EC210#KVOLV - SN CP00121943 - Year 2011

Model: EC210#KVOLV

Serial Number: CP00121943

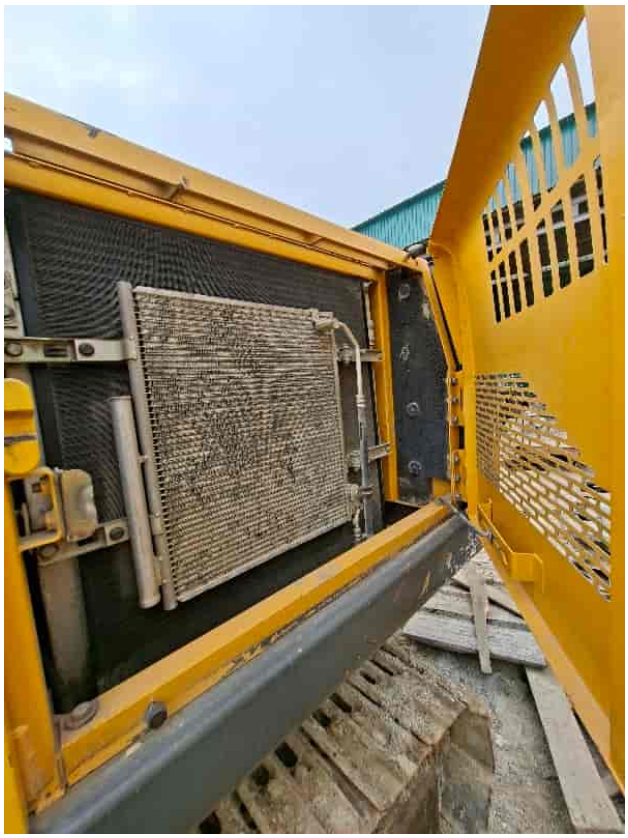
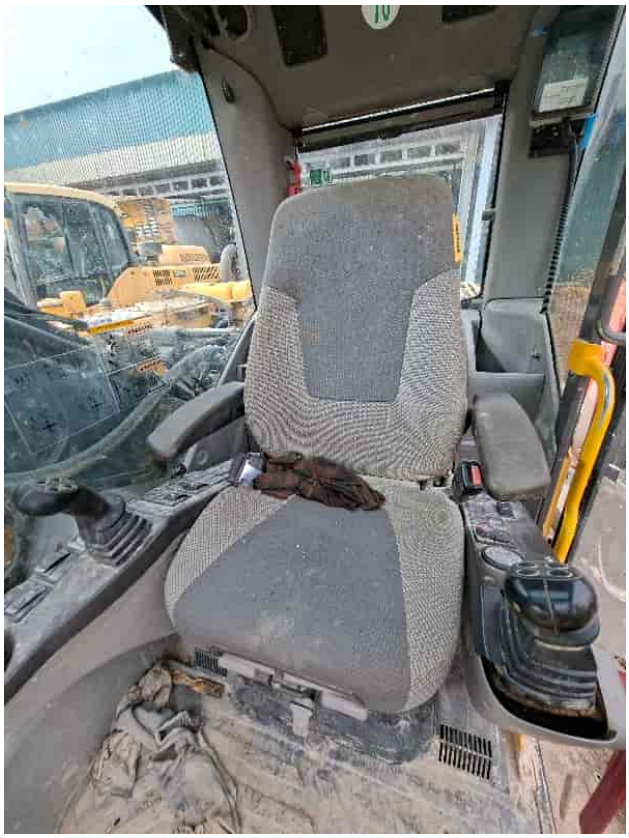
- Il contaore è: Funzionante
