SALES REPORT: CATERPILLAR 924K - SN PWR02450 - Year 2013

This Report is a summary about observations cames out from technical inspection done by our specialised technician.

Model: 924K

Serial Number: PWR02450

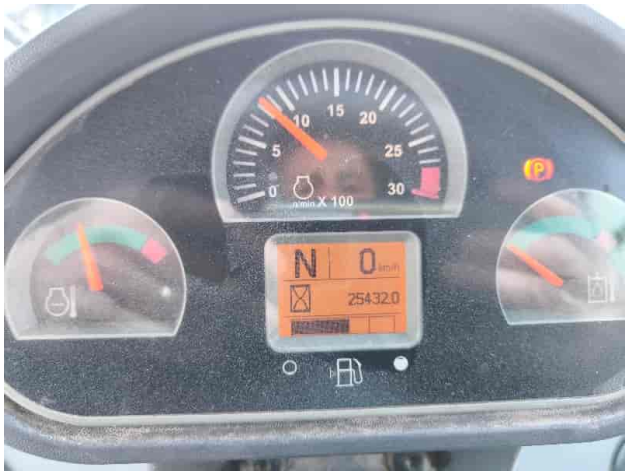
Totali
Distanza totale 112984 KM
Ore totali funzionam. 25432.0
Combust. totale 161223 L
AUTO
