SALES REPORT: CATERPILLAR 313FGC - SN GJD10177 - Year 2017

This Report is a summary about observations cames out from technical inspection done by our specialised technician.

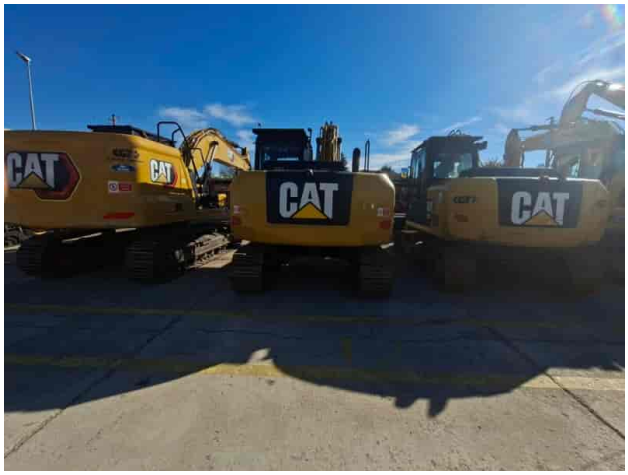
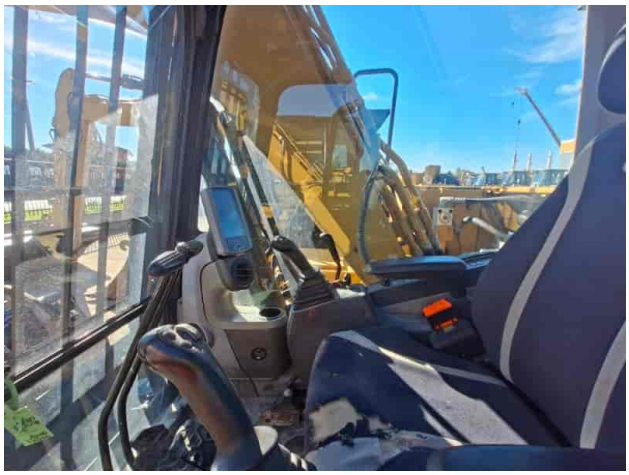
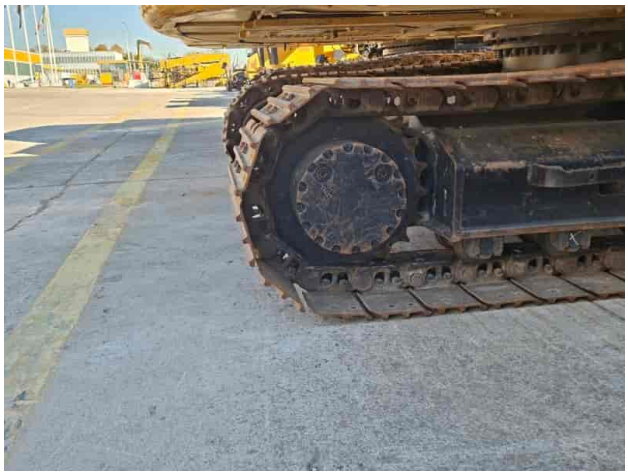
MACHINE PHOTOS

- Il contaore è: Funzionante
