SALES REPORT: CATERPILLAR 303.5 - SN CE901164 - Year 2022

This Report is a summary about observations cames out from technical inspection done by our specialised technician.

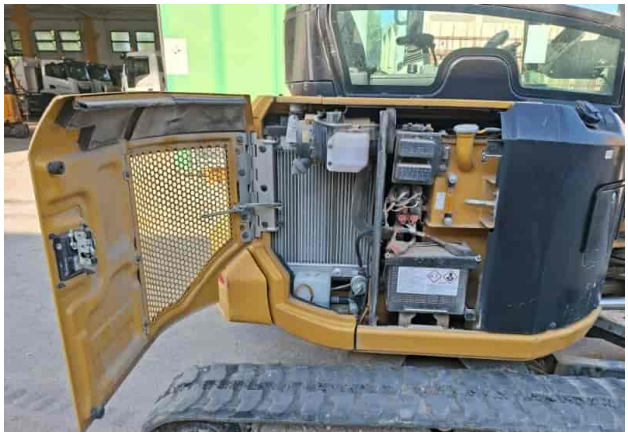
MACHINE PHOTOS

- Il contaore è: Funzionante
