SALES REPORT: CATERPILLAR 303.5 - SN CE901### - Year 2022

This Report is a summary about observations cames out from technical inspection done by our specialised technician.

Model: 303.5

Serial Number: CE901###

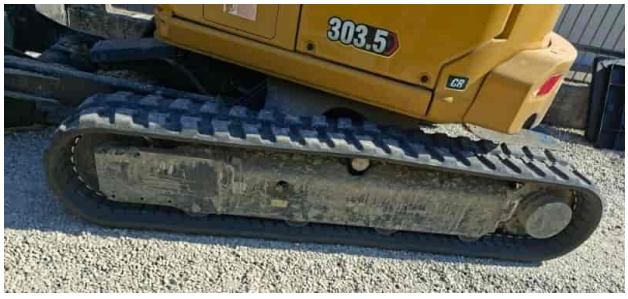
MACHINE PHOTOS

N/D	Good
N/D	Good
N/D	NA - Not applicable
N/D	MANCA IL COPRI VALVOLA DI BLOCCO (VEDI FOTO)
Hood/Armor bottom conditions:	Present and intact

N/D	No
N/D	No
N/D	No
N/D	No
N/D	Good
N/D	Good
N/D	Good
N/D	No
N/D	FARO SUL SOTTOBRACCIO DA SISTEMARE

Glass conditions:	Excellent - no needs repair
Lights conditions:	Broken or Chipped - needs repair
Rear view mirrors conditions:	Excellent - no needs repair
Stepladders & handrails conditions:	Good
Cameras conditions:	Broken or Chipped - needs repair
Flashing conditions:	Not functioning
Safety belt conditions:	Present and expired
Controls been modified:	No
Presence of Exclusion Control Lever:	Yes
	If No, are control levers protected to accidental funcionality? : Yes
Are Tools Functional & Visible with tag:	Yes
Canopy completed and comes with keys and bolt:	Yes
All Pipes with no damage e/o scratches:	Yes
Batteries box shielded:	Yes
Acustic alarm works properly:	No
Boardwalk presence:	Not present
