SALES REPORT: CATERPILLAR 313FGC - SN GJD10215 - Year 2017

This Report is a summary about observations cames out from technical inspection done by our specialised technician.

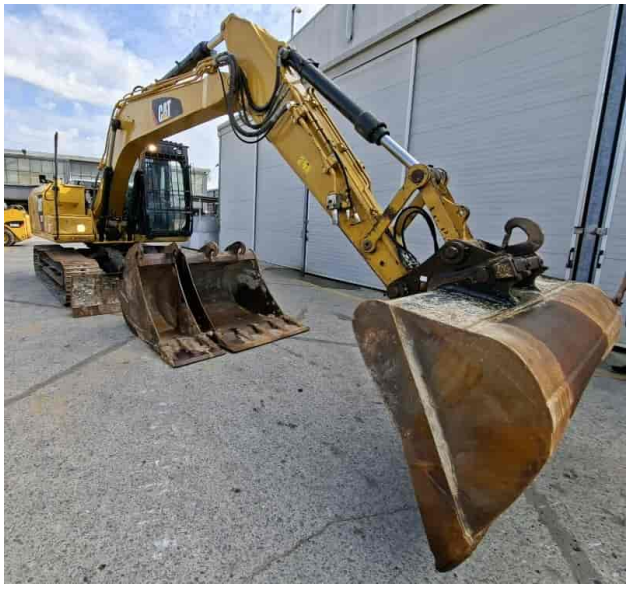
- Il contaore è: Funzionante
